## **Access Compliance Report Public Rights-of-Way** (Curb Ramps)

Intersection ID: 43359 Location: N ADA ID: D27058F50C69 Ramp Type: Perp Initial Pass/Fail: Pass **Overall Compliance: No Severity Score:** 5

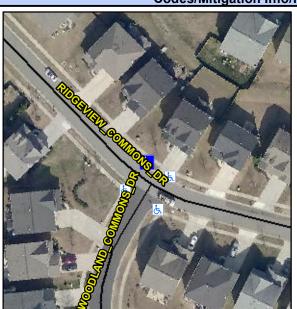
Field Measurements/Component Compliance					
Compliance Description Data		Comp	liance Description	Data	
N/A	Ramp Length (in)	72.0	Yes	Ramp Slope (%)	6.1
Yes	Ramp Width (in)	48.0	Yes	Ramp XSlope (%)	1.4
N/A	Flare Type LT	Sloped	N/A	Flare Type RT	N/A
N/A	Flare Slope LT (%)	3.6	N/A	Flare Slope RT (%)	5.9
N/A	Flare Traversable LT?	No	N/A	Flare Traversable RT?	No
Yes	Landing Length (in)	48.0	Yes	DWS Provided?	Yes
Yes	Landing Width (in)	48.0	Yes	DWS Contrast?	Yes
No	Landing Slope (%)	3.0	Yes	DWS Length (in)	24.5
Yes	Landing X Slope (%)	0.7	Yes	DWS Full Width?	Yes
N/A	Landing Curb? (Y/N)	No	Yes	DWS Offset (in)	0.0
N/A	Shared Landing?	Yes			
Yes	Gutter Ponding?	No	No	Gutter Slope (%)	5.8
Yes	Gutter Lip Ht (in)	0.0	Yes	Gutter X Slope (%)	1.1
N/A	Painted X Walk1?	No	N/A	Painted X Walk2?	N/A
	X Walk 1 Direction	To SW		X Walk 2 Direction	N/A
N/A	X Walk 1 Width (in)	N/A	N/A	X Walk 2 Width (in)	N/A
	X Walk 1 Slope (%)	0.4		X Walk 2 Slope (%)	N/A

X Walk 1 X Slope (%)	2.3		X Walk 2 X Slope (%)	N/A
N/A	Ramp inside XWalk1?	N/A	N/A	Ramp inside XWalk2?	N/A
	Road Slope (%)	N/A	N/A	Clear Space?	Yes
	Road X Slope (%)	N/A	N/A	Clear Space to XWalk (in)	N/A
Yes	Any Obstructions?	No	Yes	Storm Grate/Utility Hazard?	No
	Obstruction Type			Storm Grate/Utility Type	
		N/A			N/A
			Yes	Surface Condition? (G/P)	Good

RIDGEVIEW COMMONS DR Street 1 Name Stop Condition-Street 2 None Street 2 Name N/A Stop Condition-Street 1 N/A Possible Solutions: Remove & Replace Landing. Remove & Replace Gutter. Surveyor Notes: N/A PROW/ADA: R304.2.2-Perp, R304.3.2-Para, R304.5.4
