## Access Compliance Report Public Rights-of-Way (Curb Ramps)

Intersection ID: 22281 Main Street: SHERBOURNE\_DR Cross Street: THORNCLIFF\_DR Location: SE

ADA ID: D279CC4FB6F3 Ramp Type: BlendTrans2 Initial Pass/Fail: Fail Overall Compliance: No Severity Score: 25

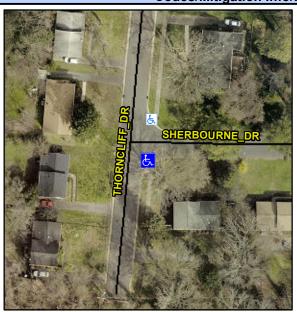
ASP LIP 1.0, RAMP LIP 0.5

PROW/ADA:
Not Found, R304.5.3

Field Measurements/Component Comphance					
Compliance Description		Data	Compliance Description		Data
N/A	Ramp Length (in)	57.0	Yes	BlendTrans Slope (%)	4.1
Yes	Ramp Width (in)	48.0	No	BlendTrans XSlope (%)	8.5
N/A	Flare Type LT	N/A	N/A	Flare Type RT	N/A
N/A	Flare Slope LT (%)	N/A	N/A	Flare Slope RT (%)	N/A
N/A	Flare Traversable LT?	N/A	N/A	Flare Traversable RT?	N/A
N/A	Landing Length (in)	N/A	N/A	DWS Provided?	N/A
N/A	Landing Width (in)	N/A	N/A	DWS Contrast?	N/A
N/A	Landing Slope (%)	N/A	N/A	DWS Length (in)	N/A
N/A	Landing X Slope (%)	N/A	N/A	DWS Full Width?	N/A
N/A	Landing Curb? (Y/N)	N/A	N/A	DWS Offset (in)	N/A
N/A	Shared Landing?	N/A			
N/A	Gutter Ponding?	N/A	N/A	Gutter Slope (%)	N/A
N/A	Gutter Lip Ht (in)	N/A	N/A	Gutter X Slope (%)	N/A
N/A	Painted X Walk1?	No	N/A	Painted X Walk2?	No
	X Walk 1 Direction	To N		X Walk 2 Direction	To W
	X Walk 1 Width (in)	N/A		X Walk 2 Width (in)	N/A
	X Walk 1 Slope (%)	12.3		X Walk 2 Slope (%)	9.3

X Walk 1 X Slope (%)	1.1		X Walk 2 X Slope (%)	10.0
N/A	Ramp inside XWalk1?	N/A	N/A	Ramp inside XWalk2?	N/A
	Road Slope (%)	5.2		Clear Space?	N/A
	Road X Slope (%)	11.4	N/A	Clear Space to XWalk (in)	N/A
N/A	Any Obstructions?	N/A	N/A	Storm Grate/Utility Hazard?	N/A
	Obstruction Type			Storm Grate/Utility Type	
		N/A			N/A

Remove & Replace Curb Ramp With
Two New Directional Ramps or
Equivalent.
