Access Compliance Report

Public Rights-of-Way

(Curb Ramps)

Intersection ID: 31904	Main Street: CHAPECLANE_RD	Cross Street: PALOMAR_MOUNTAIN_DR	Location: NW
ADA ID: D27C298636D6	Ramp Type: PerpDiag	Initial Pass/Fail: Fail	Overall Compliance: No
Severity Score: 10			
Codes/Mitigation Info/Possible Solution		Field Measurements/Component Compliance

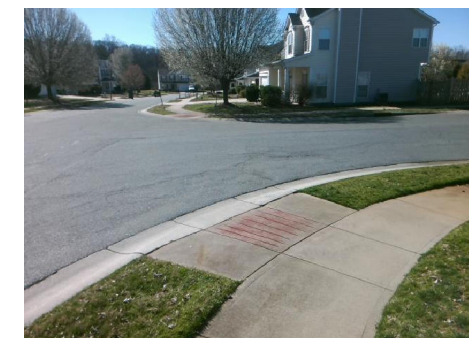
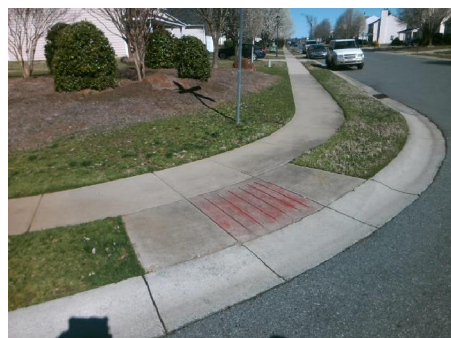
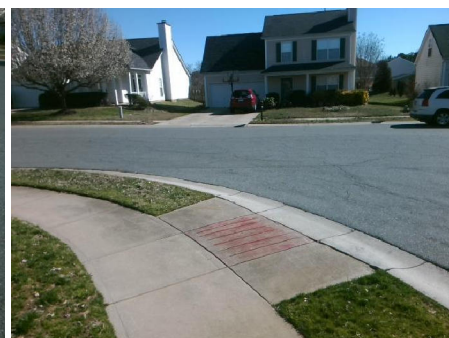
Not Found, R304.5.1, R304.5.3

Compliance	Description	Data	Compliance	Description	Data
N/A	Ramp Length (in)	48.0	Yes	Ramp Slope (%)	5.1
No	Ramp Width (in)	42.5	No	Ramp XSlope (%)	2.4
N/A	Flare Type LT	N/A	N/A	Flare Type RT	N/A
N/A	Flare Slope LT (%)	N/A	N/A	Flare Slope RT (%)	N/A
N/A	Flare Traversable LT?	N/A	N/A	Flare Traversable RT?	N/A
N/A	Landing Length (in)	N/A	N/A	DWS Provided?	N/A
N/A	Landing Width (in)	N/A	N/A	DWS Contrast?	N/A
N/A	Landing Slope (%)	N/A	N/A	DWS Length (in)	N/A
N/A	Landing X Slope (%)	N/A	N/A	DWS Full Width?	N/A
N/A	Landing Curb? (Y/N)	N/A	N/A	DWS Offset (in)	N/A
N/A	Shared Landing?	N/A			
N/A	Gutter Ponding?	N/A	N/A	Gutter Slope (%)	N/A
N/A	Gutter Lip Ht (in)	N/A	N/A	Gutter X Slope (%)	N/A
N/A	Painted X Walk1?	No	N/A	Painted X Walk2?	No
	X Walk 1 Direction	To S		X Walk 2 Direction	To E
N/A	X Walk 1 Width (in)	N/A	N/A	X Walk 2 Width (in)	N/A
	X Walk 1 Slope (%)	2.3		X Walk 2 Slope (%)	2.6
	X Walk 1 X Slope (%)	0.3		X Walk 2 X Slope (%)	0.3

N/A	Ramp inside XWalk1?	N/A	N/A	Ramp inside XWalk2?	N/A
	Road Slope (%)	1.5	N/A	Clear Space?	N/A
	Road X Slope (%)	0.6	N/A	Clear Space to XWalk (in)	N/A
N/A	Any Obstructions?	N/A	N/A	Storm Grate/Utility Hazard?	N/A
	Obstruction Type			Storm Grate/Utility Type	
		N/A			N/A
		Yes		Surface Condition? (G/P)	Good

Remove & Replace Curb Ramp With Two New Directional Ramps or Equivalent.
