# Access Compliance Report

## Public Rights-of-Way

### (Curb Ramps)

Intersection ID: 15763	Main Street: MONROE_RD	Cross Street: N_WENDOVER_RD	Location: N
ADA ID: D27F75231CFA	Ramp Type: Perp	Initial Pass/Fail: Fail	Overall Compliance: No
			Severity Score: 21.25

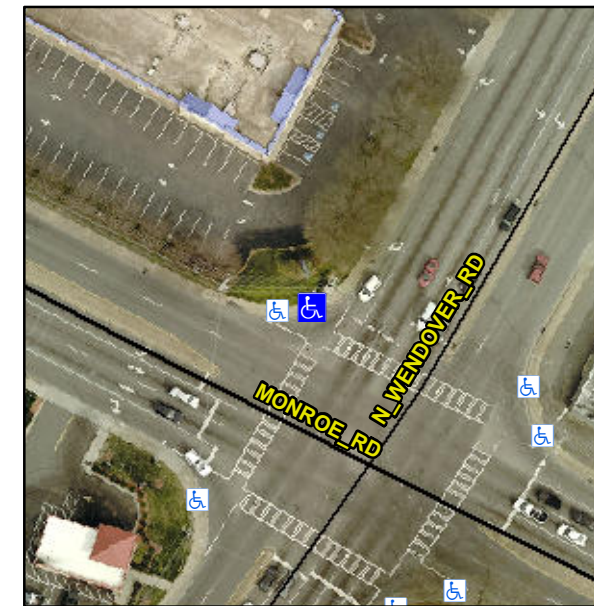
**Not Found, R304.5.1, R304.2.2**

Compliance	Description	Data	Compliance	Description	Data
N/A	Ramp Length (in)	59.0	No	Ramp Slope (%)	9.9
No	Ramp Width (in)	44.0	Yes	Ramp XSlope (%)	0.2
N/A	Flare Type LT	N/A	N/A	Flare Type RT	N/A
N/A	Flare Slope LT (%)	N/A	N/A	Flare Slope RT (%)	N/A
N/A	Flare Traversable LT?	N/A	N/A	Flare Traversable RT?	N/A
N/A	Landing Length (in)	N/A	N/A	DWS Provided?	N/A
N/A	Landing Width (in)	N/A	N/A	DWS Contrast?	N/A
N/A	Landing Slope (%)	N/A	N/A	DWS Length (in)	N/A
N/A	Landing X Slope (%)	N/A	N/A	DWS Full Width?	N/A
N/A	Landing Curb? (Y/N)	N/A	N/A	DWS Offset (in)	N/A
N/A	Shared Landing?	N/A			
N/A	Gutter Ponding?	N/A	N/A	Gutter Slope (%)	N/A
N/A	Gutter Lip Ht (in)	N/A	N/A	Gutter X Slope (%)	N/A
N/A	Painted X Walk1?	Yes	N/A	Painted X Walk2?	N/A
	X Walk 1 Direction	To SE		X Walk 2 Direction	N/A
N/A	X Walk 1 Width (in)	107.0	N/A	X Walk 2 Width (in)	N/A
	X Walk 1 Slope (%)	0.6		X Walk 2 Slope (%)	N/A
	X Walk 1 X Slope (%)	1.4		X Walk 2 X Slope (%)	N/A

N/A	Ramp inside XWalk1?	Yes	N/A	Ramp inside XWalk2?	N/A
	Road Slope (%)	N/A	N/A	Clear Space?	N/A
	Road X Slope (%)	N/A	N/A	Clear Space to XWalk (in)	N/A
N/A	Any Obstructions?	N/A	N/A	Storm Grate/Utility Hazard?	N/A
	Obstruction Type			Storm Grate/Utility Type	
		N/A			N/A
			Yes	Surface Condition? (G/P)	Good

**Remove & Replace Entire Ramp.**

Total Cost: \$ 1850.00
