# Access Compliance Report

## Public Rights-of-Way

Intersection ID: 31188	Main Street: BARBEE_DR	Cross Street: CARVER_POND_RD	Location: NE
ADA ID: D28F23ED2710	Ramp Type: BlendTrans1	Initial Pass/Fail: Fail	Overall Compliance: No
Codes/Mitigation Info/Possible Solution			Severity Score: 10
			Field Measurements/Component Compliance

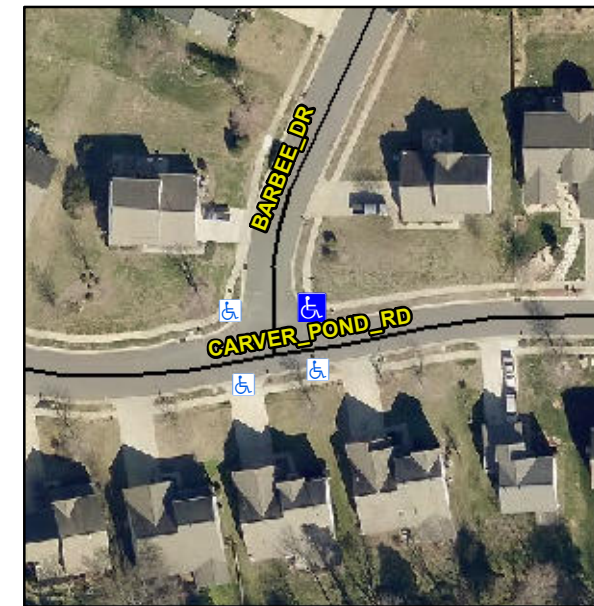
**Not Found, R304.5.1, R304.5.3**

Compliance	Description	Data	Compliance	Description	Data
N/A	Ramp Length (in)	49.0	Yes	BlendTrans Slope (%)	1.9
No	Ramp Width (in)	38.0	No	BlendTrans XSlope (%)	4.3
N/A	Flare Type LT	N/A	N/A	Flare Type RT	N/A
N/A	Flare Slope LT (%)	N/A	N/A	Flare Slope RT (%)	N/A
N/A	Flare Traversable LT?	N/A	N/A	Flare Traversable RT?	N/A
N/A	Landing Length (in)	N/A	N/A	DWS Provided?	N/A
N/A	Landing Width (in)	N/A	N/A	DWS Contrast?	N/A
N/A	Landing Slope (%)	N/A	N/A	DWS Length (in)	N/A
N/A	Landing X Slope (%)	N/A	N/A	DWS Full Width?	N/A
N/A	Landing Curb? (Y/N)	N/A	N/A	DWS Offset (in)	N/A
N/A	Shared Landing?	N/A			
N/A	Gutter Ponding?	N/A	N/A	Gutter Slope (%)	N/A
N/A	Gutter Lip Ht (in)	N/A	N/A	Gutter X Slope (%)	N/A
N/A	Painted X Walk1?	No	N/A	Painted X Walk2?	No
	X Walk 1 Direction	To W		X Walk 2 Direction	To S
	X Walk 1 Width (in)	N/A		X Walk 2 Width (in)	N/A
	X Walk 1 Slope (%)	2.9		X Walk 2 Slope (%)	2.3
	X Walk 1 X Slope (%)	4.1		X Walk 2 X Slope (%)	4.1

N/A	Ramp inside XWalk1?	N/A	N/A	Ramp inside XWalk2?	N/A
	Road Slope (%)	4.1		Clear Space?	N/A
	Road X Slope (%)	1.9	N/A	Clear Space to XWalk (in)	N/A
N/A	Any Obstructions?	N/A	N/A	Storm Grate/Utility Hazard?	N/A
	Obstruction Type			Storm Grate/Utility Type	
		N/A			N/A
			Yes	Surface Condition? (G/P)	Good
			No	Curb Slope (%)	6.0

**Remove & Replace Curb Ramp With Two New Directional Ramps or Equivalent.**
