Access Compliance Report Public Rights-of-Way (Curb Ramps)

Intersection ID: 53883Main Street: PAW_VILLAGE_RDCross Street: N/ALocation:NADA ID: D29916C419ACRamp Type: BlendTrans1Initial Pass/Fail: FailOverall Compliance: NoSeverity Score: 8.75

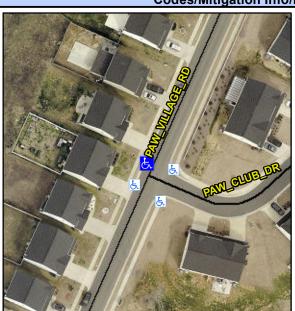
Not Found, R304.5.1

Compliance Description Da		Data	Comp	oliance Description	Data
N/A	Ramp Length (in)	49.0	Yes	BlendTrans Slope (%)	3.7
No	Ramp Width (in)	47.5	Yes	BlendTrans XSlope (%)	0.9
N/A	Flare Type LT	N/A	N/A	Flare Type RT	N/A
N/A	Flare Slope LT (%)	N/A	N/A	Flare Slope RT (%)	N/A
N/A	Flare Traversable LT?	N/A	N/A	Flare Traversable RT?	N/A
N/A	Landing Length (in)	N/A	N/A	DWS Provided?	N/A
N/A	Landing Width (in)	N/A	N/A	DWS Contrast?	N/A
N/A	Landing Slope (%)	N/A	N/A	DWS Length (in)	N/A
N/A	Landing X Slope (%)	N/A	N/A	DWS Full Width?	N/A
N/A	Landing Curb? (Y/N)	N/A	N/A	DWS Offset (in)	N/A
N/A	Shared Landing?	N/A			
N/A	Gutter Ponding?	N/A	N/A	Gutter Slope (%)	N/A
N/A	Gutter Lip Ht (in)	N/A	N/A	Gutter X Slope (%)	N/A
N/A	Painted X Walk1?	No	N/A	Painted X Walk2?	N/A
	X Walk 1 Direction	To SE		X Walk 2 Direction	N/A
	X Walk 1 Width (in)	N/A		X Walk 2 Width (in)	N/A
	X Walk 1 Slope (%)	3.7		X Walk 2 Slope (%)	N/A
	X Walk 1 X Slope (%)	2.5		X Walk 2 X Slope (%)	N/A

N/A	Ramp inside XWalk1?	N/A	N/A	Ramp inside XWalk2?	N/A
	Road Slope (%)	2.5		Clear Space?	N/A
	Road X Slope (%)	3.7	N/A	Clear Space to XWalk (in)	N/A
N/A	Any Obstructions?	N/A	N/A	Storm Grate/Utility Hazard?	N/A
	Obstruction Type			Storm Grate/Utility Type	
		N/A			N/A
			Yes	Surface Condition? (G/P)	Good
	\$		No	Curb Slope (%)	12.7

Remove & Replace Curb Ramp With Two New Directional Ramps or Equivalent.
