Access Compliance Report

Public Rights-of-Way (Curb Ramps)

Intersection ID: 11258	Main Street: CLOVER_HILL_LN	Cross Street: STEPPING_STONE_DR	Location: S
ADA ID: D29A4AD664BB	Ramp Type: Directional1	Initial Pass/Fail: Pass	Overall Compliance: No
Severity Score: 0			
Codes/Mitigation Info/Possible Solution		Field Measurements/Component Compliance

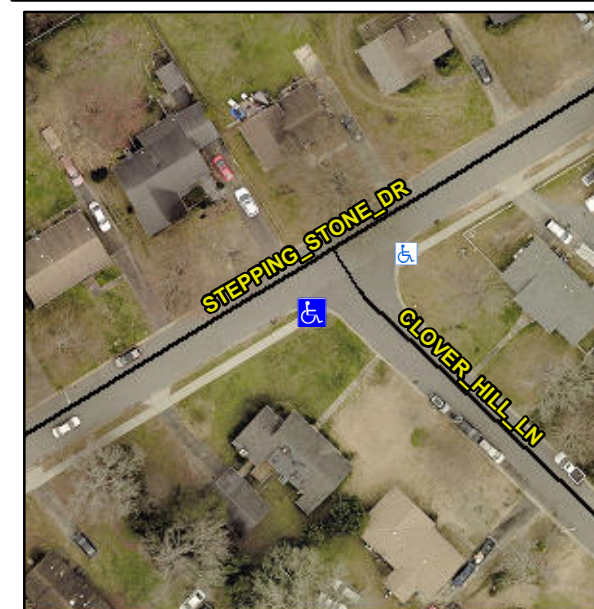
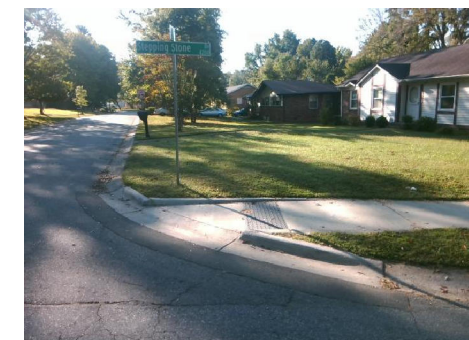
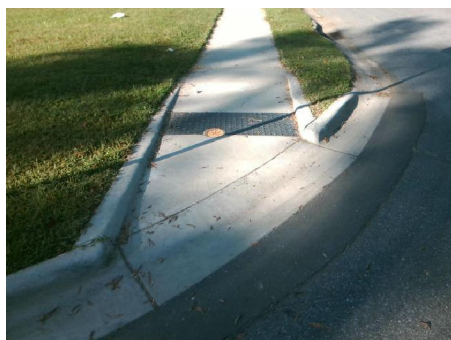
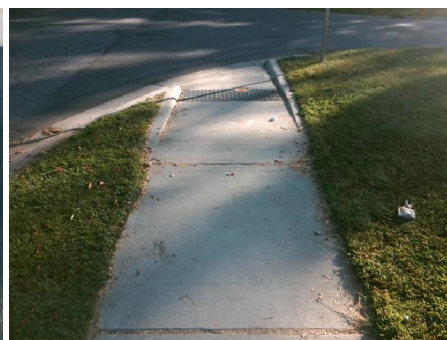
Not Found, R304.2.2-Perp, R304.3.2-Para, R305.2

Compliance	Description	Data	Compliance	Description	Data
N/A	Ramp Length (in)	73.5	N/A	Grade Break?	N/A
Yes	Ramp Width (in)	60.5	N/A	Grade Break Slope (%)	0.0
Yes	Ramp Slope (%)	0.9	N/A	Grade Break XSlope (%)	0.0
Yes	Ramp XSlope (%)	0.3			
Yes	Flare Type LT	N/A	Yes	Flare Type RT	N/A
N/A	Flare Slope LT (%)	N/A	N/A	Flare Slope RT (%)	N/A
N/A	Flare Traversable LT?	No	N/A	Flare Traversable RT?	No
Yes	Landing Length (in)	68.0	Yes	DWS Provided?	Yes
Yes	Landing Width (in)	60.0	Yes	DWS Contrast?	Yes
No	Landing Slope (%)	5.0	Yes	DWS Length (in)	24.0
Yes	Landing X Slope (%)	0.1	Yes	DWS Full Width?	Yes
N/A	Landing Curb? (Y/N)	No	No	DWS Offset LT (in)	63.0
N/A	Shared Landing?	No	Yes	DWS Offset RT (in)	1.5
Yes	Gutter Ponding?	No	Yes	Gutter Slope (%)	2.4
Yes	Gutter Lip Ht (in)	0.0	Yes	Gutter X Slope (%)	1.7
N/A	Painted X Walk1?	No		Road Slope (%)	3.0
	X Walk 1 Direction	To NE		Road X Slope (%)	1.8
	X Walk 1 Width (in)	N/A		Clear Space?	Yes

X Walk 1 Slope (%)	3.0	N/A	Clear Space to XWalk (in)	N/A
	X Walk 1 X Slope (%)	1.8	Yes	Storm Grate/Utility Hazard?	No
N/A	Ramp inside XWalk1?	N/A		Storm Grate/Utility Type	
Yes	Any Obstructions?	No			N/A
	Obstruction Type		Yes	Surface Condition? (G/P)	Good
			N/A	Curb Slope (%)	13.5

Remove & Replace Entire Ramp.
