# Access Compliance Report

## Public Rights-of-Way

### (Curb Ramps)

Intersection ID: 10017494	Main Street: MILHAVEN_LN	Cross Street: N/A	Location: SW
ADA ID: D29F37E9BB72	Ramp Type: Perp	Initial Pass/Fail: Fail	Overall Compliance: No
Severity Score: 25			
Codes/Mitigation Info/Possible Solution		Field Measurements/Component Compliance

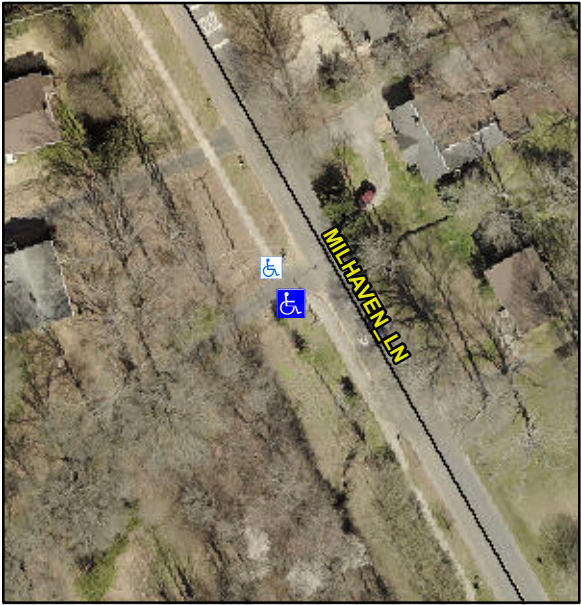
Possible Solutions:	Compliance	Description	Data	Compliance	Description	Data
	Remove & Replace Entire Ramp.	N/A	Ramp Length (in)	31.0	No	Ramp Slope (%)	8.8
		Yes	Ramp Width (in)	62.5	No	Ramp XSlope (%)	5.9
		N/A	Flare Type LT	N/A	N/A	Flare Type RT	N/A
		N/A	Flare Slope LT (%)	N/A	N/A	Flare Slope RT (%)	N/A
		N/A	Flare Traversable LT?	N/A	N/A	Flare Traversable RT?	N/A
		N/A	Landing Length (in)	N/A	N/A	DWS Provided?	N/A
		N/A	Landing Width (in)	N/A	N/A	DWS Contrast?	N/A
		N/A	Landing Slope (%)	N/A	N/A	DWS Length (in)	N/A
		N/A	Landing X Slope (%)	N/A	N/A	DWS Full Width?	N/A
		N/A	Landing Curb? (Y/N)	N/A	N/A	DWS Offset (in)	N/A
		N/A	Shared Landing?	N/A			
		N/A	Gutter Ponding?	N/A	N/A	Gutter Slope (%)	N/A
		N/A	Gutter Lip Ht (in)	N/A	N/A	Gutter X Slope (%)	N/A
		N/A	Painted X Walk1?	No	N/A	Painted X Walk2?	N/A
			X Walk 1 Direction	To N		X Walk 2 Direction	N/A
		N/A	X Walk 1 Width (in)	N/A	N/A	X Walk 2 Width (in)	N/A

X Walk 1 Slope (%)	5.0		X Walk 2 Slope (%)	N/A
			X Walk 1 X Slope (%)	5.6		X Walk 2 X Slope (%)	N/A
		N/A	Ramp inside XWalk1?	N/A	N/A	Ramp inside XWalk2?	N/A
<p>Surveyor Notes:</p> <p>N/A</p> <p>PROW/ADA:</p> <p>Not Found, R304.2.2, R304.5.3</p>			Road Slope (%)	N/A	N/A	Clear Space?	N/A
			Road X Slope (%)	N/A	N/A	Clear Space to XWalk (in)	N/A
		N/A	Any Obstructions?	N/A	N/A	Storm Grate/Utility Hazard?	N/A
			Obstruction Type			Storm Grate/Utility Type	
					N/A		N/A
					Yes	Surface Condition? (G/P)	Good
