Access Compliance Report Public Rights-of-Way (Curb Ramps)

Intersection ID: 45644 Main Street: W 5TH ST Cross Street: W_6TH_ST Location: Ε

Overall Compliance: No ADA ID: D2A5DD54F328 Ramp Type: BlendTrans1 Initial Pass/Fail: Pass **Severity Score:** 7.5

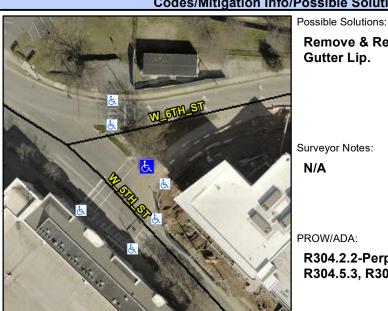
Compliance Description		Data	Compliance Description		Data
N/A	Ramp Length (in)	71.0	Yes	BlendTrans Slope (%)	4.7
Yes	Ramp Width (in)	48.0	Yes	BlendTrans XSlope (%)	1.5
N/A	Flare Type LT	None	N/A	Flare Type RT	Sloped
N/A	Flare Slope LT (%)	N/A	N/A	Flare Slope RT (%)	4.1
N/A	Flare Traversable LT?	N/A	N/A	Flare Traversable RT?	No
Yes	Landing Length (in)	85.0	Yes	DWS Provided?	Yes
Yes	Landing Width (in)	71.0	Yes	DWS Contrast?	Yes
No	Landing Slope (%)	2.9	Yes	DWS Length (in)	24.0
No	Landing X Slope (%)	3.8	Yes	DWS Full Width?	Yes
N/A	Landing Curb? (Y/N)	No	Yes	DWS Offset (in)	2.0
N/A	Shared Landing?	No			
Yes	Gutter Ponding?	No	Yes	Gutter Slope (%)	1.8
No	Gutter Lip Ht (in)	0.5	Yes	Gutter X Slope (%)	1.0
N/A	Painted X Walk1?	Yes	N/A	Painted X Walk2?	N/A
	X Walk 1 Direction	To SE		X Walk 2 Direction	N/A
	X Walk 1 Width (in)	111.0		X Walk 2 Width (in)	N/A
	X Walk 1 Slope (%)	3.2		X Walk 2 Slope (%)	N/A
	X Walk 1 X Slope (%)	3.7		X Walk 2 X Slope (%)	N/A

Yes	Ramp inside XWalk1?	Yes	N/A	Ramp inside XWalk2?	N/A
	Road Slope (%)	3.7		Clear Space?	Yes
	Road X Slope (%)	3.2	N/A	Clear Space to XWalk (in)	N/A
Yes	Any Obstructions?	No	Yes	Storm Grate/Utility Hazard?	No
	Obstruction Type			Storm Grate/Utility Type	
		N/A			N/A
			Yes	Surface Condition? (G/P)	Good

W 6TH ST Street 1 Name Stop Condition-Street 1 Signal Street 2 Name N/A Stop Condition-Street 2 N/A Remove & Replace Landing. Grind Gutter Lip.

PROW/ADA: R304.2.2-Perp, R304.3.2-Para, R304.5.3, R302.7.2

Total Cost: 700.00
