Access Compliance Report

Public Rights-of-Way

(Curb Ramps)

Intersection ID: 11512	Main Street: N_SMITH_ST	Cross Street: W_7TH_ST	Location: N
ADA ID: D2AC4EF70B38	Ramp Type: PerpDiag	Initial Pass/Fail: Fail	Overall Compliance: No
		Severity Score: 55

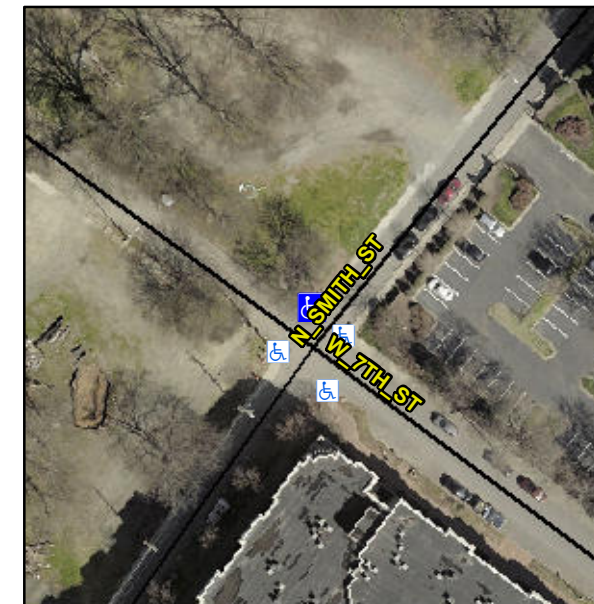
Compliance	Description	Data	Compliance	Description	Data
N/A	Ramp Length (in)	50.0	No	Ramp Slope (%)	8.7
No	Ramp Width (in)	32.0	No	Ramp XSlope (%)	8.1
N/A	Flare Type LT	N/A	N/A	Flare Type RT	N/A
N/A	Flare Slope LT (%)	N/A	N/A	Flare Slope RT (%)	N/A
N/A	Flare Traversable LT?	N/A	N/A	Flare Traversable RT?	N/A
N/A	Landing Length (in)	N/A	N/A	DWS Provided?	N/A
N/A	Landing Width (in)	N/A	N/A	DWS Contrast?	N/A
N/A	Landing Slope (%)	N/A	N/A	DWS Length (in)	N/A
N/A	Landing X Slope (%)	N/A	N/A	DWS Full Width?	N/A
N/A	Landing Curb? (Y/N)	N/A	N/A	DWS Offset (in)	N/A
N/A	Shared Landing?	N/A			
N/A	Gutter Ponding?	N/A	N/A	Gutter Slope (%)	N/A
N/A	Gutter Lip Ht (in)	N/A	N/A	Gutter X Slope (%)	N/A
N/A	Painted X Walk1?	No	N/A	Painted X Walk2?	No
	X Walk 1 Direction	To SW		X Walk 2 Direction	To SE
N/A	X Walk 1 Width (in)	N/A	N/A	X Walk 2 Width (in)	N/A
	X Walk 1 Slope (%)	3.5		X Walk 2 Slope (%)	2.3
	X Walk 1 X Slope (%)	5.5		X Walk 2 X Slope (%)	1.2

N/A	Ramp inside XWalk1?	N/A	N/A	Ramp inside XWalk2?	N/A
	Road Slope (%)	6.0	N/A	Clear Space?	N/A
	Road X Slope (%)	0.8	N/A	Clear Space to XWalk (in)	N/A
N/A	Any Obstructions?	N/A	N/A	Storm Grate/Utility Hazard?	N/A
	Obstruction Type			Storm Grate/Utility Type	
		N/A			N/A
			Yes	Surface Condition? (G/P)	Good

Remove & Replace Curb Ramp With Two New Directional Ramps or Equivalent.

R304.5.1, R304.2.2, R304.5.3
