Access Compliance Report

Public Rights-of-Way

(Curb Ramps)

Intersection ID: 2973	Main Street: GREEN_HEDGE_AV	Cross Street: WHITE_ASPEN_PL	Location: W
ADA ID: D2BA434ED30F	Ramp Type: BlendTrans1	Initial Pass/Fail: Fail	Overall Compliance: No
Severity Score: 18.75			
Codes/Mitigation Info/Possible Solution		Field Measurements/Component Compliance

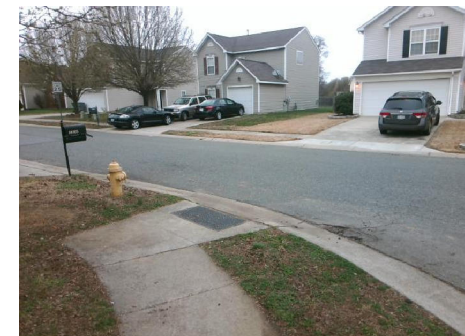
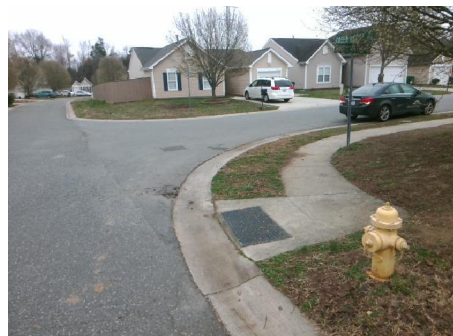
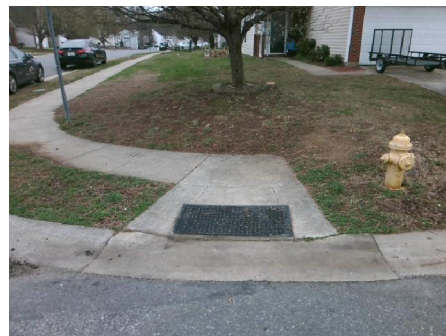
Compliance	Description	Data	Compliance	Description	Data
N/A	Ramp Length (in)	47.0	Yes	BlendTrans Slope (%)	3.9
No	Ramp Width (in)	33.0	No	BlendTrans XSlope (%)	3.8
N/A	Flare Type LT	N/A	N/A	Flare Type RT	N/A
N/A	Flare Slope LT (%)	N/A	N/A	Flare Slope RT (%)	N/A
N/A	Flare Traversable LT?	N/A	N/A	Flare Traversable RT?	N/A
N/A	Landing Length (in)	N/A	N/A	DWS Provided?	N/A
N/A	Landing Width (in)	N/A	N/A	DWS Contrast?	N/A
N/A	Landing Slope (%)	N/A	N/A	DWS Length (in)	N/A
N/A	Landing X Slope (%)	N/A	N/A	DWS Full Width?	N/A
N/A	Landing Curb? (Y/N)	N/A	N/A	DWS Offset (in)	N/A
N/A	Shared Landing?	N/A			
N/A	Gutter Ponding?	N/A	N/A	Gutter Slope (%)	N/A
N/A	Gutter Lip Ht (in)	N/A	N/A	Gutter X Slope (%)	N/A
N/A	Painted X Walk1?	No	N/A	Painted X Walk2?	N/A
	X Walk 1 Direction	To NE		X Walk 2 Direction	N/A
	X Walk 1 Width (in)	N/A		X Walk 2 Width (in)	N/A
	X Walk 1 Slope (%)	2.2		X Walk 2 Slope (%)	N/A
	X Walk 1 X Slope (%)	1.7		X Walk 2 X Slope (%)	N/A

N/A	Ramp inside XWalk1?	N/A	N/A	Ramp inside XWalk2?	N/A
	Road Slope (%)	1.7		Clear Space?	N/A
	Road X Slope (%)	2.2	N/A	Clear Space to XWalk (in)	N/A
N/A	Any Obstructions?	N/A	N/A	Storm Grate/Utility Hazard?	N/A
	Obstruction Type			Storm Grate/Utility Type	
		N/A			N/A
			Yes	Surface Condition? (G/P)	Good
			N/A	Curb Slope (%)	2.0

Remove & Replace Curb Ramp With Two New Directional Ramps or Equivalent.
