# Access Compliance Report

## Public Rights-of-Way

### (Curb Ramps)

| Intersection ID: 10014712 | Main Street: NORLAND_RD | Cross Street: N/A | Location: S |

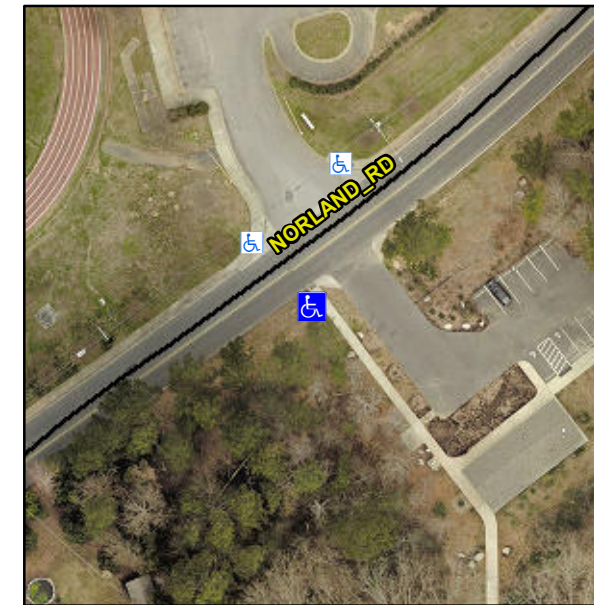
| ADA ID: D2BF9AA98886 | Ramp Type: BlendTrans1 | Initial Pass/Fail: Pass | Overall Compliance: No |
| | | Severity Score: 7.5 | |

| Compliance | Description | Data | Compliance | Description | Data |
|---|---|---|---|---|---|
| No | Landing Slope (%) | 2.6 | Yes | DWS Length (in) | 24.0 |
| Yes | Landing X Slope (%) | 0.1 | No | DWS Full Width? | No |
| N/A | Landing Curb? (Y/N) | No | No | DWS Offset (in) | 3.0 |
| Yes | Gutter Ponding? | No | No | Gutter Slope (%) | 6.3 |

**Remove & Replace Curb Ramp With Two New Directional Ramps or Equivalent. Remove & Replace Gutter.**
