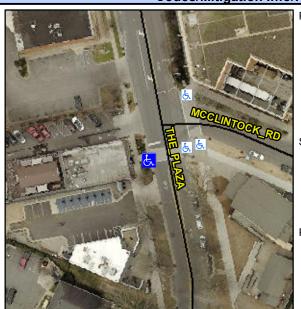
| Possible Solutions: |
|---|
| Not Found, R304.2.2-Perp, R304.3.2- |

| Compliance Description Data | | Comp | liance | Description | Data | |
|---|---|---|---|---|---|---|
| No | Landing Slope (%) | 3.6 | Yes | DWS | Length (in) | 24.0 |

| Possible Solutions: |
|---|
| Remove & Replace Entire Ramp. |
