# Access Compliance Report

## Public Rights-of-Way

### (Curb Ramps)

Intersection ID: 13817	Main Street: SHENANDOAH_AV	Cross Street: WESTOVER_ST	Location: W
ADA ID: D2CBF3479778	Ramp Type: PerpDiag	Initial Pass/Fail: Fail	Overall Compliance: No
Severity Score: 22.5			
Codes/Mitigation Info/Possible Solution		Field Measurements/Component Compliance

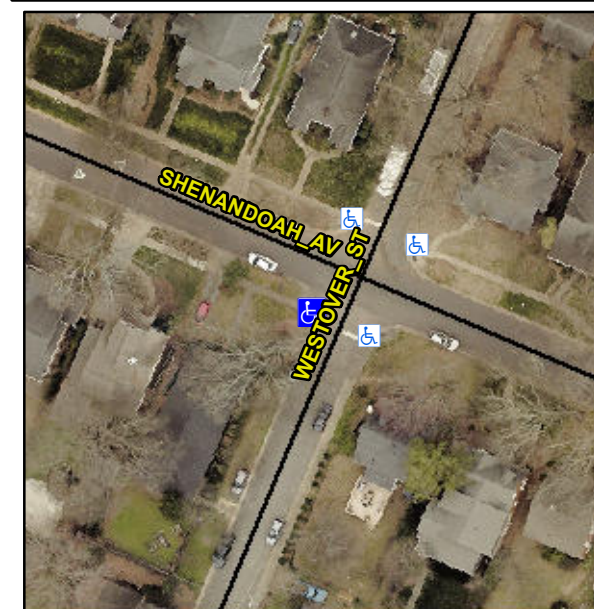
Compliance	Description	Data	Compliance	Description	Data
N/A	Ramp Length (in)	61.0	No	Ramp Slope (%)	9.4
No	Ramp Width (in)	38.0	No	Ramp XSlope (%)	4.0
N/A	Flare Type LT	N/A	N/A	Flare Type RT	N/A
N/A	Flare Slope LT (%)	N/A	N/A	Flare Slope RT (%)	N/A
N/A	Flare Traversable LT?	N/A	N/A	Flare Traversable RT?	N/A
N/A	Landing Length (in)	N/A	N/A	DWS Provided?	N/A
N/A	Landing Width (in)	N/A	N/A	DWS Contrast?	N/A
N/A	Landing Slope (%)	N/A	N/A	DWS Length (in)	N/A
N/A	Landing X Slope (%)	N/A	N/A	DWS Full Width?	N/A
N/A	Landing Curb? (Y/N)	N/A	N/A	DWS Offset (in)	N/A
N/A	Shared Landing?	N/A			
N/A	Gutter Ponding?	N/A	N/A	Gutter Slope (%)	N/A
N/A	Gutter Lip Ht (in)	1.0	N/A	Gutter X Slope (%)	N/A
N/A	Painted X Walk1?	No	N/A	Painted X Walk2?	No
	X Walk 1 Direction	To NE		X Walk 2 Direction	To SE
N/A	X Walk 1 Width (in)	N/A	N/A	X Walk 2 Width (in)	N/A
	X Walk 1 Slope (%)	0.3		X Walk 2 Slope (%)	4.4
	X Walk 1 X Slope (%)	5.3		X Walk 2 X Slope (%)	2.1

N/A	Ramp inside XWalk1?	N/A	N/A	Ramp inside XWalk2?	N/A
	Road Slope (%)	2.2	N/A	Clear Space?	N/A
	Road X Slope (%)	2.5	N/A	Clear Space to XWalk (in)	N/A
N/A	Any Obstructions?	N/A	N/A	Storm Grate/Utility Hazard?	N/A
	Obstruction Type			Storm Grate/Utility Type	
		N/A			N/A
			Yes	Surface Condition? (G/P)	Good

Possible Solutions:

**Remove & Replace Curb Ramp With Two New Directional Ramps or Equivalent.**
