# Access Compliance Report

## Public Rights-of-Way

### (Curb Ramps)

Intersection ID: 42757	Main Street: ELAM_CT	Cross Street: LEES_CROSSING_DR	Location: S
ADA ID: D2CDD16A4E75	Ramp Type: BlendTrans1	Initial Pass/Fail: Fail	Overall Compliance: No
		Severity Score: 10

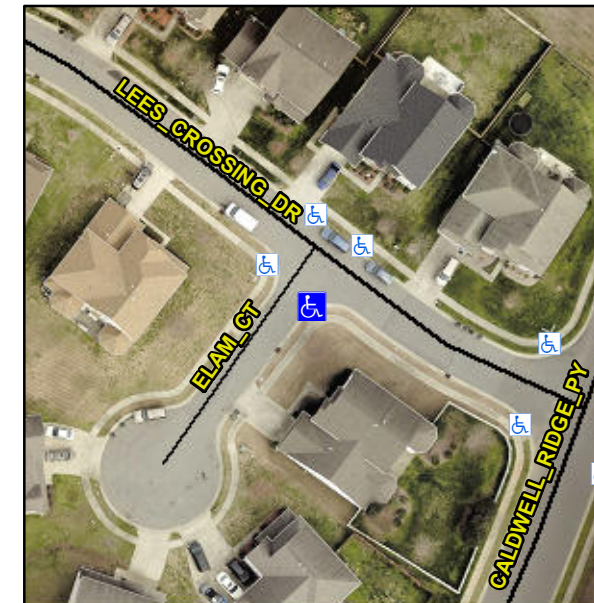
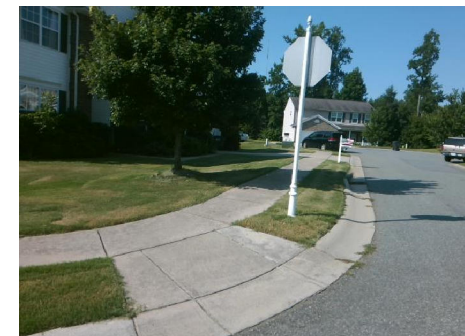
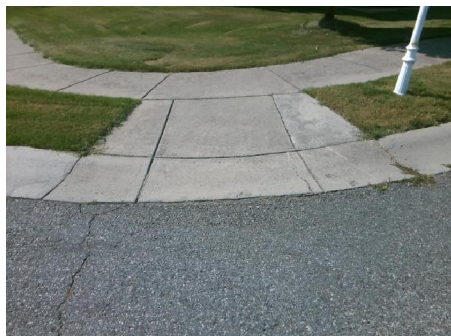
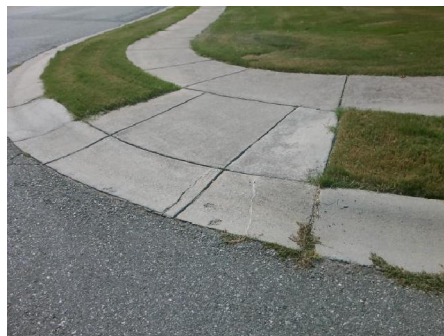
**RP < 5%**

**Not Found, R304.5.1, R304.5.3**

Compliance	Description	Data	Compliance	Description	Data
N/A	Ramp Length (in)	52.0	Yes	BlendTrans Slope (%)	3.5
No	Ramp Width (in)	45.0	No	BlendTrans XSlope (%)	3.7
N/A	Flare Type LT	N/A	N/A	Flare Type RT	N/A
N/A	Flare Slope LT (%)	N/A	N/A	Flare Slope RT (%)	N/A
N/A	Flare Traversable LT?	N/A	N/A	Flare Traversable RT?	N/A
N/A	Landing Length (in)	N/A	N/A	DWS Provided?	N/A
N/A	Landing Width (in)	N/A	N/A	DWS Contrast?	N/A
N/A	Landing Slope (%)	N/A	N/A	DWS Length (in)	N/A
N/A	Landing X Slope (%)	N/A	N/A	DWS Full Width?	N/A
N/A	Landing Curb? (Y/N)	N/A	N/A	DWS Offset (in)	N/A
N/A	Shared Landing?	N/A			
N/A	Gutter Ponding?	N/A	N/A	Gutter Slope (%)	N/A
N/A	Gutter Lip Ht (in)	N/A	N/A	Gutter X Slope (%)	N/A
N/A	Painted X Walk1?	No	N/A	Painted X Walk2?	No
	X Walk 1 Direction	To W		X Walk 2 Direction	To E
	X Walk 1 Width (in)	N/A		X Walk 2 Width (in)	N/A
	X Walk 1 Slope (%)	1.2		X Walk 2 Slope (%)	5.0
	X Walk 1 X Slope (%)	5.6		X Walk 2 X Slope (%)	2.0

N/A	Ramp inside XWalk1?	N/A	N/A	Ramp inside XWalk2?	N/A
	Road Slope (%)	2.2		Clear Space?	N/A
	Road X Slope (%)	5.0	N/A	Clear Space to XWalk (in)	N/A
N/A	Any Obstructions?	N/A	N/A	Storm Grate/Utility Hazard?	N/A
	Obstruction Type			Storm Grate/Utility Type	
		N/A			N/A
			Yes	Surface Condition? (G/P)	Good
			No	Curb Slope (%)	9.0

**Remove & Replace Curb Ramp With Two New Directional Ramps or Equivalent.**
