Access Compliance Report

Public Rights-of-Way (Curb Ramps)

Intersection ID: 21340		Main Street: CHAMPAIGN_ST		Cross Street: SHARON_RD		Location: SW											
ADA ID: D2D4701912C6		Ramp Type: Directional1		Initial Pass/Fail: Fail		Overall Compliance: No		Severity Score: 1.25									
Codes/Mitigation Info/Possible Solution				Field Measurements/Component Compliance													
<div>

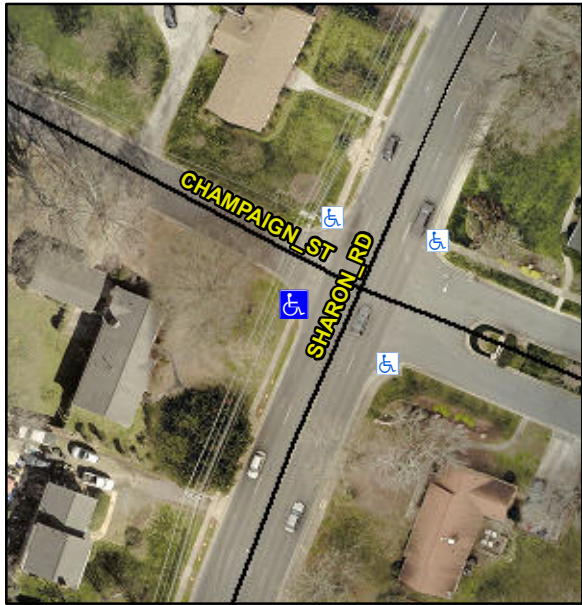
</div> <div>Possible Solutions:</div> <div>Remove & Replace Entire Ramp.</div> <div>Surveyor Notes:</div> <div>N/A</div> <div>PROW/ADA:</div> <div>R304.5.3</div> <div>Street 1 Name</div> <div>CHAMPAIGN ST</div> <div>Stop Condition-Street 1</div> <div>StopSign</div> <div>Street 2 Name</div> <div>N/A</div> <div>Stop Condition-Street 2</div> <div>N/A</div> <div>Total Cost:</div> <div>\$</div> <div>1600.00</div>				Compliance		Description		Data		Compliance		Description		Data			
				N/A		Ramp Length (in)		91.0		N/A		Grade Break?		N/A		N/A	
				Yes		Ramp Width (in)		48.0		N/A		Grade Break Slope (%)		0.0		0.0

Yes		Ramp Slope (%)		2.3		N/A		Grade Break XSlope (%)		0.0		0.0	
				No		Ramp XSlope (%)		4.3									
				N/A		Flare Type LT		N/A		N/A		Flare Type RT		N/A		N/A	
				N/A		Flare Slope LT (%)		N/A		N/A		Flare Slope RT (%)		0.0		0.0	
				N/A		Flare Traversable LT?		N/A		N/A		Flare Traversable RT?		N/A		N/A	
				N/A		Landing Length (in)		0.0		N/A		DWS Provided?		N/A		N/A	
				N/A		Landing Width (in)		0.0		N/A		DWS Contrast?		N/A		N/A	
				N/A		Landing Slope (%)		0.0		N/A		DWS Length (in)		N/A		N/A	
				N/A		Landing X Slope (%)		0.0		N/A		DWS Full Width?		N/A		N/A	
				N/A		Landing Curb? (Y/N)		N/A		N/A		DWS Offset LT (in)		N/A		N/A	
				N/A		Shared Landing?		N/A		N/A		DWS Offset RT (in)		N/A		N/A	
				N/A		Gutter Ponding?		0.0		N/A		Gutter Slope (%)		N/A		N/A	
				N/A		Gutter Lip Ht (in)		0.0		N/A		Gutter X Slope (%)		N/A		N/A	
				N/A		Painted X Walk1?		No				Road Slope (%)		6.0		6.0	
						X Walk 1 Direction		To N				Road X Slope (%)		2.5		2.5

X Walk 1 Width (in)		N/A				Clear Space?		N/A		N/A	
						X Walk 1 Slope (%)		6.0		N/A		Clear Space to XWalk (in)		N/A		N/A	
						X Walk 1 X Slope (%)		2.5		N/A		Storm Grate/Utility Hazard?		N/A		N/A	
				N/A		Ramp inside XWalk1?		N/A				Storm Grate/Utility Type					
				N/A		Any Obstructions?		N/A						N/A		N/A	
						Obstruction Type				Yes		Surface Condition? (G/P)		Good		Good	
										N/A		N/A		Curb Slope (%)		2.5
