# Access Compliance Report

## Public Rights-of-Way

### (Curb Ramps)

Intersection ID: 51507	Main Street: ALDERSON_DR	Cross Street: NETHERTON_LN	Location:	N
ADA ID: D2DAA78882D1	Ramp Type: BlendTrans1	Initial Pass/Fail: Fail	Overall Compliance: No	Severity Score: 10
Codes/Mitigation Info/Possible Solution		Field Measurements/Component Compliance

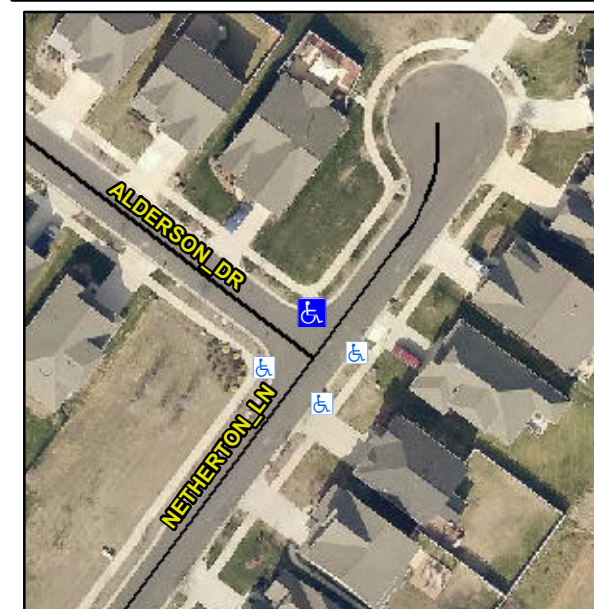
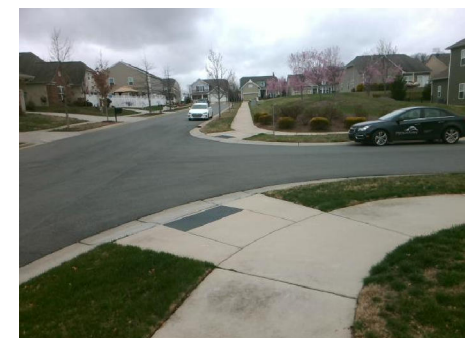
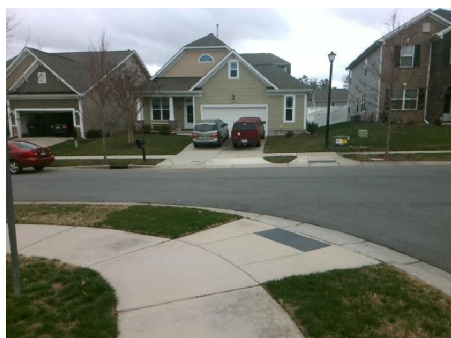
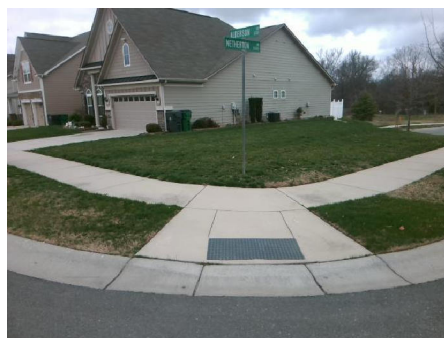
**Not Found, R304.5.1, R304.5.3**

Compliance	Description	Data	Compliance	Description	Data
N/A	Ramp Length (in)	71.5	Yes	BlendTrans Slope (%)	4.9
No	Ramp Width (in)	42.0	No	BlendTrans XSlope (%)	3.8
N/A	Flare Type LT	N/A	N/A	Flare Type RT	N/A
N/A	Flare Slope LT (%)	N/A	N/A	Flare Slope RT (%)	N/A
N/A	Flare Traversable LT?	N/A	N/A	Flare Traversable RT?	N/A
N/A	Landing Length (in)	N/A	N/A	DWS Provided?	N/A
N/A	Landing Width (in)	N/A	N/A	DWS Contrast?	N/A
N/A	Landing Slope (%)	N/A	N/A	DWS Length (in)	N/A
N/A	Landing X Slope (%)	N/A	N/A	DWS Full Width?	N/A
N/A	Landing Curb? (Y/N)	N/A	N/A	DWS Offset (in)	N/A
N/A	Shared Landing?	N/A			
N/A	Gutter Ponding?	N/A	N/A	Gutter Slope (%)	N/A
N/A	Gutter Lip Ht (in)	N/A	N/A	Gutter X Slope (%)	N/A
N/A	Painted X Walk1?	No	N/A	Painted X Walk2?	No
	X Walk 1 Direction	To SW		X Walk 2 Direction	To SE
	X Walk 1 Width (in)	N/A		X Walk 2 Width (in)	N/A
	X Walk 1 Slope (%)	3.6		X Walk 2 Slope (%)	2.8
	X Walk 1 X Slope (%)	2.1		X Walk 2 X Slope (%)	4.4

N/A	Ramp inside XWalk1?	N/A	N/A	Ramp inside XWalk2?	N/A
	Road Slope (%)	1.3		Clear Space?	N/A
	Road X Slope (%)	4.7	N/A	Clear Space to XWalk (in)	N/A
N/A	Any Obstructions?	N/A	N/A	Storm Grate/Utility Hazard?	N/A
	Obstruction Type			Storm Grate/Utility Type	
		N/A			N/A
			Yes	Surface Condition? (G/P)	Good
			No	Curb Slope (%)	19.1

**Remove & Replace Curb Ramp With Two New Directional Ramps or Equivalent.**
