Access Compliance Report

Public Rights-of-Way

(Curb Ramps)

Intersection ID: 13190	Main Street: W_BLAND_ST	Cross Street: S_CHURCH_ST	Location: S
ADA ID: D2E080E4C467	Ramp Type: PerpDiag	Initial Pass/Fail: Fail	Overall Compliance: No
Severity Score: 13.75			
Codes/Mitigation Info/Possible Solution		Field Measurements/Component Compliance

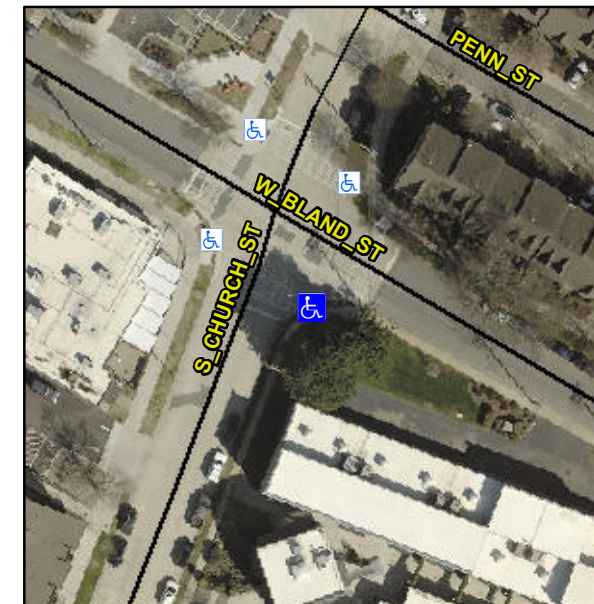
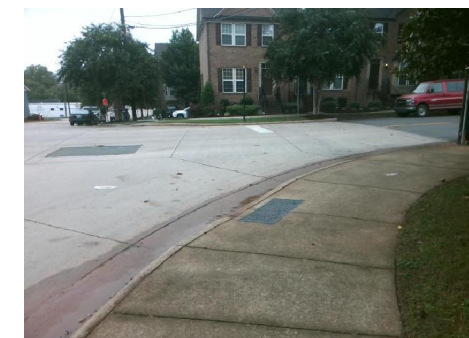
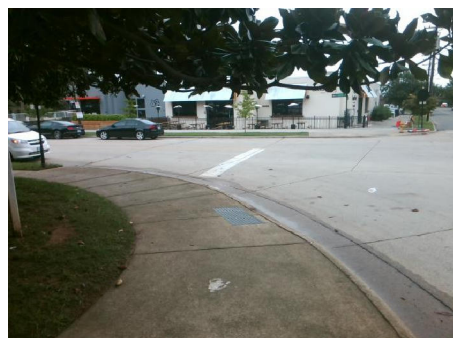
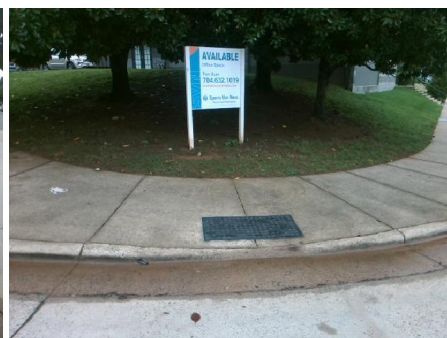
Not Found, R304.2.2, R304.5.3

Compliance	Description	Data	Compliance	Description	Data
N/A	Ramp Length (in)	95.0	No	Ramp Slope (%)	9.3
Yes	Ramp Width (in)	48.0	No	Ramp XSlope (%)	4.0
N/A	Flare Type LT	N/A	N/A	Flare Type RT	N/A
N/A	Flare Slope LT (%)	N/A	N/A	Flare Slope RT (%)	N/A
N/A	Flare Traversable LT?	N/A	N/A	Flare Traversable RT?	N/A
N/A	Landing Length (in)	N/A	N/A	DWS Provided?	N/A
N/A	Landing Width (in)	N/A	N/A	DWS Contrast?	N/A
N/A	Landing Slope (%)	N/A	N/A	DWS Length (in)	N/A
N/A	Landing X Slope (%)	N/A	N/A	DWS Full Width?	N/A
N/A	Landing Curb? (Y/N)	N/A	N/A	DWS Offset (in)	N/A
N/A	Shared Landing?	N/A			
N/A	Gutter Ponding?	N/A	N/A	Gutter Slope (%)	N/A
N/A	Gutter Lip Ht (in)	N/A	N/A	Gutter X Slope (%)	N/A
N/A	Painted X Walk1?	No	N/A	Painted X Walk2?	No
	X Walk 1 Direction	To NE		X Walk 2 Direction	To NW
N/A	X Walk 1 Width (in)	N/A	N/A	X Walk 2 Width (in)	N/A
	X Walk 1 Slope (%)	4.0		X Walk 2 Slope (%)	3.0
	X Walk 1 X Slope (%)	0.7		X Walk 2 X Slope (%)	3.5

N/A	Ramp inside XWalk1?	N/A	N/A	Ramp inside XWalk2?	N/A
	Road Slope (%)	2.3	N/A	Clear Space?	N/A
	Road X Slope (%)	2.8	N/A	Clear Space to XWalk (in)	N/A
N/A	Any Obstructions?	N/A	N/A	Storm Grate/Utility Hazard?	N/A
	Obstruction Type			Storm Grate/Utility Type	
		N/A			N/A
			Yes	Surface Condition? (G/P)	Good

Remove & Replace Curb Ramp With Two New Directional Ramps or Equivalent.
