Access Compliance Report

Public Rights-of-Way

(Curb Ramps)

Intersection ID: 51542	Main Street: GLENBURN_LN	Cross Street: DULNIAN_WY	Location: SW
ADA ID: D2E439C9A662	Ramp Type: BlendTrans1	Initial Pass/Fail: Pass	Overall Compliance: No
		Severity Score: 15

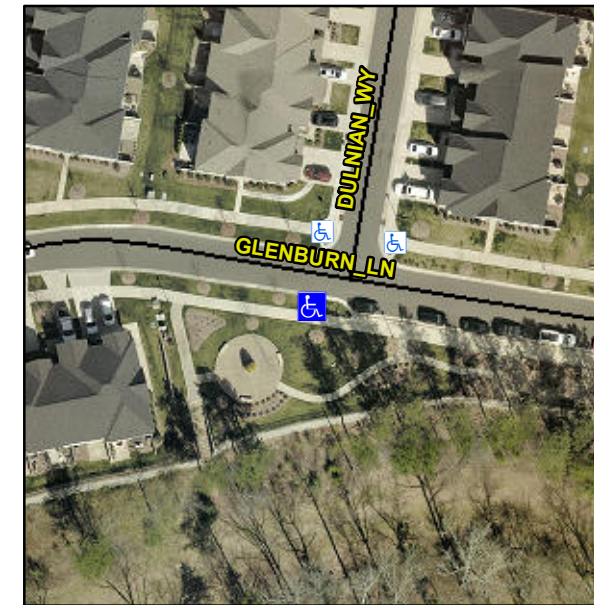
Not Found, R305, R304.5.4

Compliance	Description	Data	Compliance	Description	Data
N/A	Ramp Length (in)	93.0	Yes	BlendTrans Slope (%)	3.9
Yes	Ramp Width (in)	50.0	Yes	BlendTrans XSlope (%)	0.2
N/A	Flare Type LT	Sloped	N/A	Flare Type RT	Sloped
N/A	Flare Slope LT (%)	5.0	N/A	Flare Slope RT (%)	2.4
N/A	Flare Traversable LT?	No	N/A	Flare Traversable RT?	No
Yes	Landing Length (in)	72.0	No	DWS Provided?	No
Yes	Landing Width (in)	76.0	N/A	DWS Contrast?	No
Yes	Landing Slope (%)	1.8	N/A	DWS Length (in)	N/A
Yes	Landing X Slope (%)	1.4	N/A	DWS Full Width?	No
N/A	Landing Curb? (Y/N)	No	N/A	DWS Offset (in)	N/A
N/A	Shared Landing?	No			
Yes	Gutter Ponding?	No	No	Gutter Slope (%)	5.6
Yes	Gutter Lip Ht (in)	0.0	Yes	Gutter X Slope (%)	1.2
N/A	Painted X Walk1?	No	N/A	Painted X Walk2?	N/A
	X Walk 1 Direction	To N		X Walk 2 Direction	N/A
	X Walk 1 Width (in)	N/A		X Walk 2 Width (in)	N/A
	X Walk 1 Slope (%)	3.1		X Walk 2 Slope (%)	N/A
	X Walk 1 X Slope (%)	0.7		X Walk 2 X Slope (%)	N/A

N/A	Ramp inside XWalk1?	N/A	N/A	Ramp inside XWalk2?	N/A
	Road Slope (%)	0.7		Clear Space?	Yes
	Road X Slope (%)	3.1	N/A	Clear Space to XWalk (in)	N/A
Yes	Any Obstructions?	No	Yes	Storm Grate/Utility Hazard?	No
	Obstruction Type			Storm Grate/Utility Type	
		N/A			N/A
			Yes	Surface Condition? (G/P)	Good
			No	Curb Slope (%)	9.0

Remove & Replace Curb Ramp With Two New Directional Ramps or Equivalent. Remove & Replace Gutter.
