## Access Compliance Report Public Rights-of-Way (Curb Ramps)

Intersection ID: 27178Main Street: MCKEE\_RDCross Street: SIKES\_PLLocation:SWADA ID: D2E9328A27FBRamp Type: PerpInitial Pass/Fail: FailOverall Compliance: NoSeverity Score:25

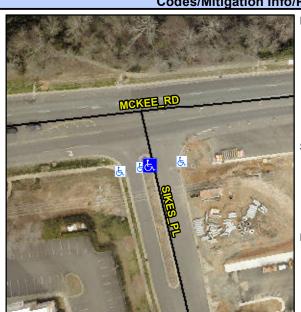
Comp	liance Description	Data	Comp	liance Description	Data
N/A	Ramp Length (in)	31.0	No	Ramp Slope (%)	14.9
Yes	Ramp Width (in)	58.5	Yes	Ramp XSlope (%)	0.9
N/A	Flare Type LT	N/A	N/A	Flare Type RT	N/A
N/A	Flare Slope LT (%)	N/A	N/A	Flare Slope RT (%)	N/A
N/A	Flare Traversable LT?	N/A	N/A	Flare Traversable RT?	N/A
N/A	Landing Length (in)	N/A	N/A	DWS Provided?	N/A
N/A	Landing Width (in)	N/A	N/A	DWS Contrast?	N/A
N/A	Landing Slope (%)	N/A	N/A	DWS Length (in)	N/A
N/A	Landing X Slope (%)	N/A	N/A	DWS Full Width?	N/A
N/A	Landing Curb? (Y/N)	N/A	N/A	DWS Offset (in)	N/A
N/A	Shared Landing?	N/A			
N/A	Gutter Ponding?	N/A	N/A	Gutter Slope (%)	N/A
N/A	Gutter Lip Ht (in)	N/A	N/A	Gutter X Slope (%)	N/A
N/A	Painted X Walk1?	No	N/A	Painted X Walk2?	N/A
	X Walk 1 Direction	To E		X Walk 2 Direction	N/A
N/A	X Walk 1 Width (in)	N/A	N/A	X Walk 2 Width (in)	N/A
	X Walk 1 Slope (%)	2.8		X Walk 2 Slope (%)	N/A
	X Walk 1 X Slope (%)	2.7		X Walk 2 X Slope (%)	N/A

i ossible colution	
Possible Solutions:	Co
Remove & Replace Entire Ramp.	N/A
	Ye
	N/A
	N/A
	N/A
	N/A
Surveyor Notes:	N/A
N/A	N/A
	N/A
	N/A
	N/A
PROW/ADA:	N/A
R304.2.2	N/A
	N/A
	N/A
	N//

1850.00
