# Access Compliance Report

## Public Rights-of-Way

### (Curb Ramps)

| Intersection ID: 43842 | Main Street: BRADSTREET COMMONS WY | Cross Street: DELUCA DR | Location: NW |

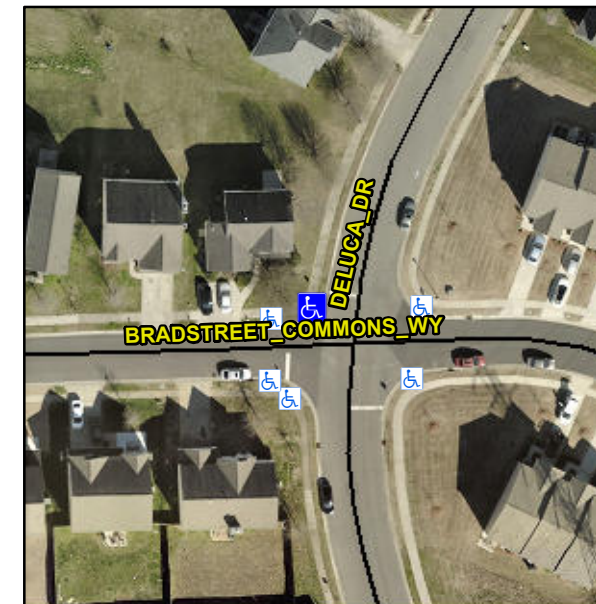
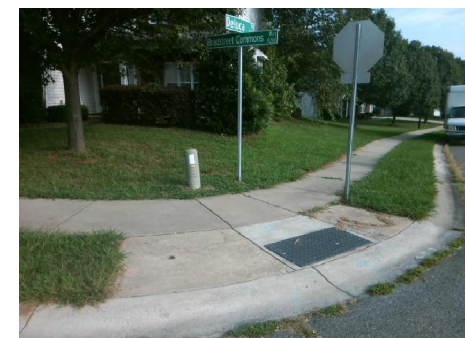
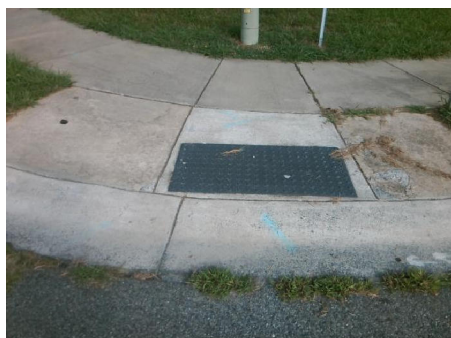
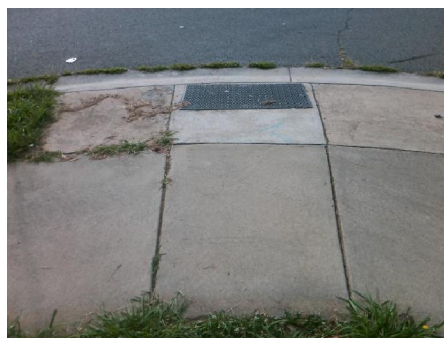
| ADA ID: D2F1076CA183 | Ramp Type: BlendTrans1 | Initial Pass/Fail: Pass | Overall Compliance: No |

**RP < 5%**

**Not Found, R304.5.3, R304.2.1, R304.2.2-Perp, R304.3.2-Para, R305.1.4, R304.5.4**

| Compliance | Description | Data | Compliance | Description | Data |
|---|---|---|---|---|---|
| Yes | Ramp Width (in) | 49.0 | No | BlendTrans XSlope (%) | 2.6 |
| No | Landing Width (in) | 34.5 | Yes | DWS Contrast? | Yes |
| No | Landing Slope (%) | 2.6 | Yes | DWS Length (in) | 24.0 |
| No | Landing X Slope (%) | 5.8 | No | DWS Full Width? | No |
| Yes | Gutter Ponding? | No | No | Gutter Slope (%) | 6.5 |
| Yes | Gutter Lip Ht (in) | 0.0 | No | Gutter X Slope (%) | 2.2 |
| | | | No | Curb Slope (%) | 27.6 |

**Remove & Replace Curb Ramp With Two New Directional Ramps or Equivalent. Remove & Replace Gutter.**
