Access Compliance Report

Public Rights-of-Way

(Curb Ramps)

Intersection ID: 12680	Main Street: W_MOREHEAD_ST	Cross Street: S_MINT_ST	Location: SE
ADA ID: D2F2DE47693D	Ramp Type: Perp	Initial Pass/Fail: Pass	Overall Compliance: No
		Severity Score: 0

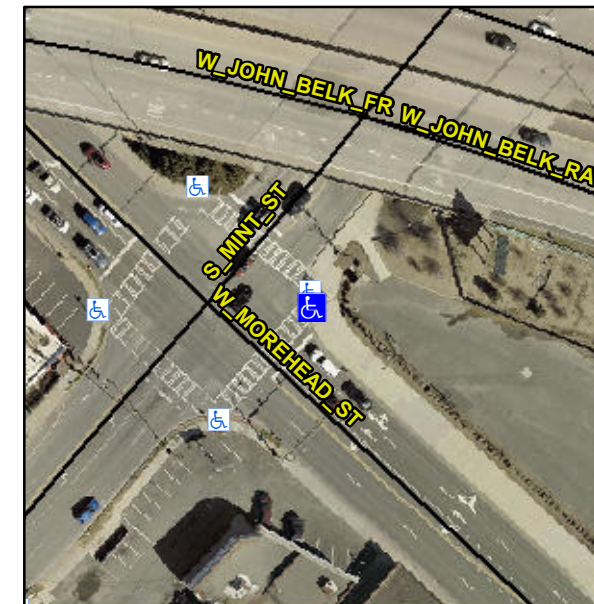
Not Found, R304.5.3, R305.2

Compliance	Description	Data	Compliance	Description	Data
N/A	Ramp Length (in)	97.0	Yes	Ramp Slope (%)	6.3
Yes	Ramp Width (in)	71.0	Yes	Ramp XSlope (%)	1.5
N/A	Flare Type LT	Sloped	N/A	Flare Type RT	N/A
N/A	Flare Slope LT (%)	4.1	Yes	Flare Slope RT (%)	7.4
N/A	Flare Traversable LT?	Yes	N/A	Flare Traversable RT?	Yes
Yes	Landing Length (in)	95.0	Yes	DWS Provided?	Yes
Yes	Landing Width (in)	71.0	Yes	DWS Contrast?	Yes
Yes	Landing Slope (%)	1.2	Yes	DWS Length (in)	24.0
No	Landing X Slope (%)	2.2	Yes	DWS Full Width?	Yes
N/A	Landing Curb? (Y/N)	No	No	DWS Offset (in)	3.0
N/A	Shared Landing?	No			
Yes	Gutter Ponding?	No	Yes	Gutter Slope (%)	1.0
Yes	Gutter Lip Ht (in)	0.0	Yes	Gutter X Slope (%)	0.3
N/A	Painted X Walk1?	Yes	N/A	Painted X Walk2?	N/A
	X Walk 1 Direction	To SW		X Walk 2 Direction	N/A
N/A	X Walk 1 Width (in)	110.0	N/A	X Walk 2 Width (in)	N/A
	X Walk 1 Slope (%)	1.9		X Walk 2 Slope (%)	N/A
	X Walk 1 X Slope (%)	1.1		X Walk 2 X Slope (%)	N/A

Yes	Ramp inside XWalk1?	Yes	N/A	Ramp inside XWalk2?	N/A
	Road Slope (%)	N/A	N/A	Clear Space?	Yes
	Road X Slope (%)	N/A	N/A	Clear Space to XWalk (in)	N/A
Yes	Any Obstructions?	No	Yes	Storm Grate/Utility Hazard?	No
	Obstruction Type			Storm Grate/Utility Type	
		N/A			N/A
			Yes	Surface Condition? (G/P)	Good

Remove & Replace Entire Ramp.
