# Access Compliance Report

## Public Rights-of-Way

| Intersection ID: 30500 | Main Street: ORCHARD_GRASS_CT | Cross Street: YOUNG_FAWN_CT | Location: NE |
| ADA ID: D2F7D365E12A | Ramp Type: PerpDiag | Initial Pass/Fail: Fail | Overall Compliance: No |

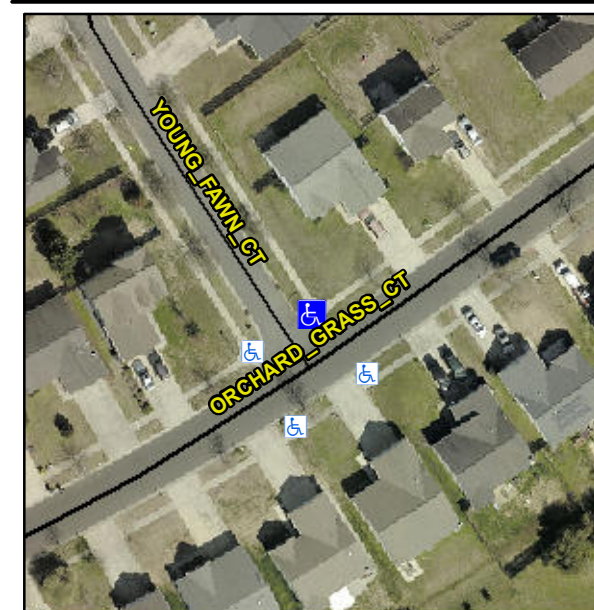
| Severity Score: 8.75 | | | |

**R304.5.1**

| Compliance | Description | Data | Compliance | Description | Data |
|---|---|---|---|---|---|
| No | Ramp Width (in) | 38.0 | Yes | Ramp XSlope (%) | 0.1 |

**Remove & Replace Curb Ramp With Two New Directional Ramps or Equivalent.**

Total Cost: \$ 3200.00
