# Access Compliance Report

## Public Rights-of-Way

### (Curb Ramps)

Intersection ID: 12958	Main Street: E_3RD_ST	Cross Street: S_DAVIDSON_ST	Location: E
ADA ID: D2F96F224A6D	Ramp Type: PerpDiag	Initial Pass/Fail: Pass	Overall Compliance: No
		Severity Score: 7.5

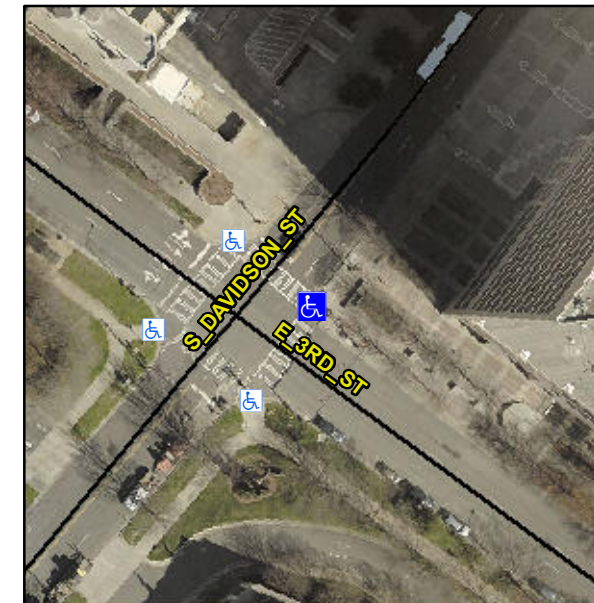
**N/A**

Compliance	Description	Data	Compliance	Description	Data
N/A	Ramp Length (in)	82.0	Yes	Ramp Slope (%)	1.5
Yes	Ramp Width (in)	72.0	Yes	Ramp XSlope (%)	2.0
N/A	Flare Type LT	Sloped	N/A	Flare Type RT	N/A
N/A	Flare Slope LT (%)	3.5	Yes	Flare Slope RT (%)	0.5
N/A	Flare Traversable LT?	Yes	N/A	Flare Traversable RT?	Yes
Yes	Landing Length (in)	48.0	Yes	DWS Provided?	Yes
Yes	Landing Width (in)	48.0	Yes	DWS Contrast?	Yes
Yes	Landing Slope (%)	0.8	Yes	DWS Length (in)	24.0
No	Landing X Slope (%)	2.5	Yes	DWS Full Width?	Yes
N/A	Landing Curb? (Y/N)	No	No	DWS Offset (in)	6.5
N/A	Shared Landing?	No			
Yes	Gutter Ponding?	No	Yes	Gutter Slope (%)	2.5
No	Gutter Lip Ht (in)	0.5	Yes	Gutter X Slope (%)	0.7
N/A	Painted X Walk1?	Yes	N/A	Painted X Walk2?	Yes
	X Walk 1 Direction	To NW		X Walk 2 Direction	To SW
N/A	X Walk 1 Width (in)	111.0	N/A	X Walk 2 Width (in)	108.0
	X Walk 1 Slope (%)	4.1		X Walk 2 Slope (%)	3.1
	X Walk 1 X Slope (%)	1.7		X Walk 2 X Slope (%)	1.2

Yes	Ramp inside XWalk1?	Yes	Yes	Ramp inside XWalk2?	Yes
	Road Slope (%)	1.2	N/A	Clear Space?	Yes
	Road X Slope (%)	4.8	Yes	Clear Space to XWalk (in)	64.0
Yes	Any Obstructions?	No	Yes	Storm Grate/Utility Hazard?	No
	Obstruction Type			Storm Grate/Utility Type	
		N/A			N/A
			Yes	Surface Condition? (G/P)	Good

**Remove & Replace Curb Ramp With Two New Directional Ramps or Equivalent. Grind Gutter Lip.**

**R304.5.3, R305.2, R302.7.2**

Total Cost: \$ 3400.00
