Access Compliance Report

Public Rights-of-Way (Curb Ramps)

Intersection ID: 6415	Main Street: ELIZABETH_RD	Cross Street: LAKE_DR	Location: W
ADA ID: D31230D2C537	Ramp Type: Perp	Initial Pass/Fail: Fail	Overall Compliance: No
			Severity Score: 58.75

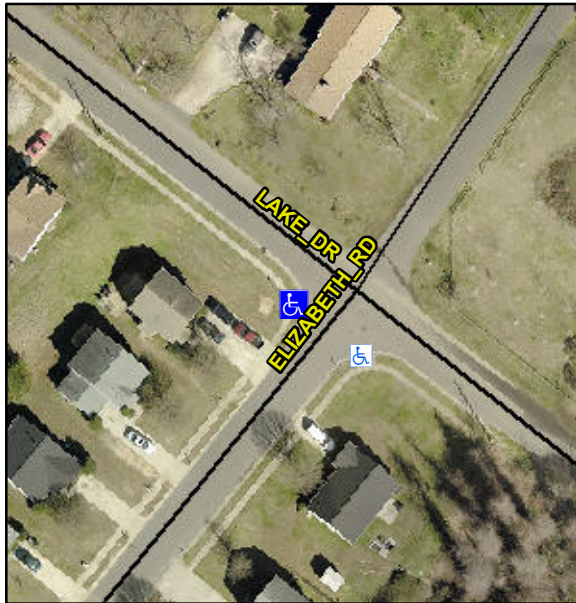
**Not Found, R304.5.1, R304.2.2,
R304.5.3**

Compliance	Description	Data	Compliance	Description	Data
N/A	Ramp Length (in)	47.0	No	Ramp Slope (%)	13.1
No	Ramp Width (in)	39.5	No	Ramp XSlope (%)	15.9
N/A	Flare Type LT	N/A	N/A	Flare Type RT	N/A
N/A	Flare Slope LT (%)	N/A	N/A	Flare Slope RT (%)	N/A
N/A	Flare Traversable LT?	N/A	N/A	Flare Traversable RT?	N/A
N/A	Landing Length (in)	N/A	N/A	DWS Provided?	N/A
N/A	Landing Width (in)	N/A	N/A	DWS Contrast?	N/A
N/A	Landing Slope (%)	N/A	N/A	DWS Length (in)	N/A
N/A	Landing X Slope (%)	N/A	N/A	DWS Full Width?	N/A
N/A	Landing Curb? (Y/N)	N/A	N/A	DWS Offset (in)	N/A
N/A	Shared Landing?	N/A			
N/A	Gutter Ponding?	N/A	N/A	Gutter Slope (%)	N/A
N/A	Gutter Lip Ht (in)	N/A	N/A	Gutter X Slope (%)	N/A
N/A	Painted X Walk1?	No	N/A	Painted X Walk2?	N/A
	X Walk 1 Direction	To SE		X Walk 2 Direction	N/A
N/A	X Walk 1 Width (in)	N/A	N/A	X Walk 2 Width (in)	N/A
	X Walk 1 Slope (%)	4.7		X Walk 2 Slope (%)	N/A
	X Walk 1 X Slope (%)	16.2		X Walk 2 X Slope (%)	N/A

N/A	Ramp inside XWalk1?	N/A	N/A	Ramp inside XWalk2?	N/A
	Road Slope (%)	N/A	N/A	Clear Space?	N/A
	Road X Slope (%)	N/A	N/A	Clear Space to XWalk (in)	N/A
N/A	Any Obstructions?	N/A	N/A	Storm Grate/Utility Hazard?	N/A
	Obstruction Type			Storm Grate/Utility Type	
		N/A			N/A
			Yes	Surface Condition? (G/P)	Good

Remove & Replace Entire Ramp.
