# Access Compliance Report

## Public Rights-of-Way

### (Curb Ramps)

| Intersection ID: 44701 | Main Street: MARY_BLAIR_LN | Cross Street: EAGLES_LANDING_DR | Location: | N |

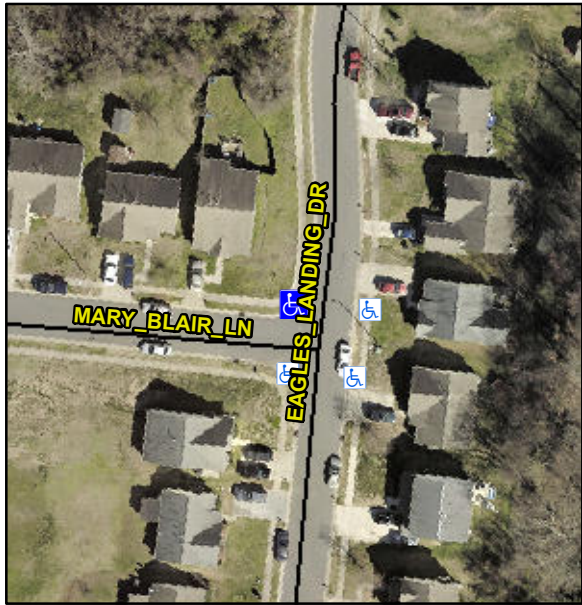
| ADA ID: D31A418F604B | Ramp Type: PerpDiag | Initial Pass/Fail: Fail | Overall Compliance: No | Severity Score: 33.75 |

| Codes/Mitigation Info/Possible Solution | | | Field Measurements/Component Compliance | | | | | |
|---|---|---|---|---|---|---|---|---|
| | | | No | Ramp Width (in) | 47.5 | No | Ramp XSlope (%) | 8.2 |
| Not Found, R304.5.1, R304.5.3 | | | N/A | Gutter Ponding? | N/A | N/A | Gutter Slope (%) | N/A |

| Codes/Mitigation Info/Possible Solution | | | Field Measurements/Component Compliance | | | | | |
|---|---|---|---|---|---|---|---|---|
| | Remove & Replace Curb Ramp With Two New Directional Ramps or Equivalent. | | N/A | Ramp Length (in) | 47.0 | Yes | Ramp Slope (%) | 5.0 |
