# Access Compliance Report

## Public Rights-of-Way

### (Curb Ramps)

Intersection ID: 3908	Main Street: BULLE_ROCK_CT	Cross Street: WOODCOCK_LN	Location: NE
ADA ID: D32CAD97DE9E	Ramp Type: Perp	Initial Pass/Fail: Fail	Overall Compliance: No
Severity Score: 1.25			
Codes/Mitigation Info/Possible Solution		Field Measurements/Component Compliance

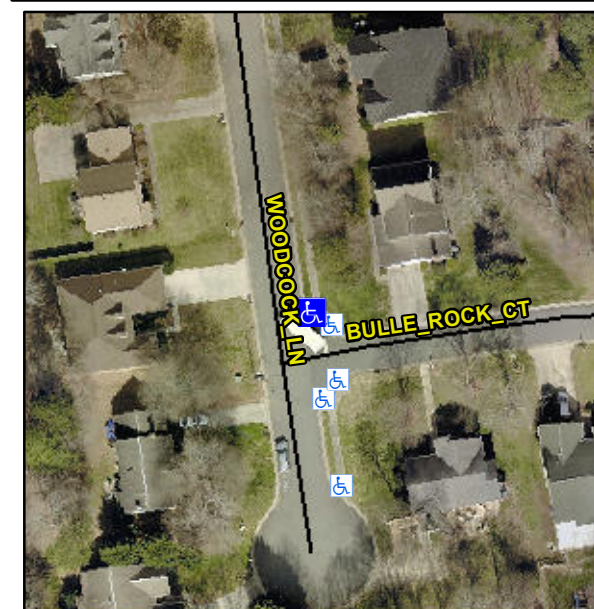
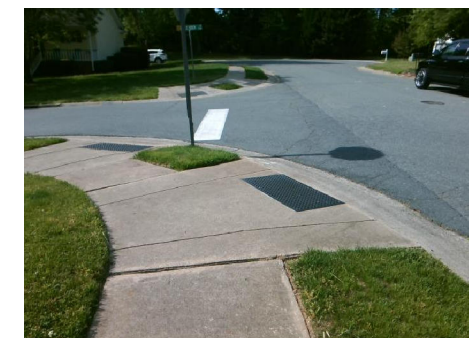
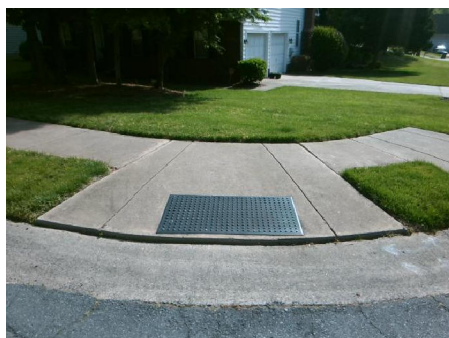
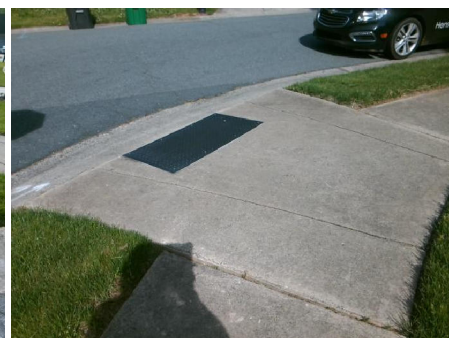
Compliance	Description	Data	Compliance	Description	Data
N/A	Ramp Length (in)	46.0	Yes	Ramp Slope (%)	6.4
Yes	Ramp Width (in)	55.0	No	Ramp XSlope (%)	2.3
N/A	Flare Type LT	N/A	N/A	Flare Type RT	N/A
N/A	Flare Slope LT (%)	N/A	N/A	Flare Slope RT (%)	N/A
N/A	Flare Traversable LT?	N/A	N/A	Flare Traversable RT?	N/A
N/A	Landing Length (in)	N/A	N/A	DWS Provided?	N/A
N/A	Landing Width (in)	N/A	N/A	DWS Contrast?	N/A
N/A	Landing Slope (%)	N/A	N/A	DWS Length (in)	N/A
N/A	Landing X Slope (%)	N/A	N/A	DWS Full Width?	N/A
N/A	Landing Curb? (Y/N)	N/A	N/A	DWS Offset (in)	N/A
N/A	Shared Landing?	N/A			
N/A	Gutter Ponding?	N/A	N/A	Gutter Slope (%)	N/A
N/A	Gutter Lip Ht (in)	N/A	N/A	Gutter X Slope (%)	N/A
N/A	Painted X Walk1?	No	N/A	Painted X Walk2?	N/A
	X Walk 1 Direction	To W		X Walk 2 Direction	N/A
N/A	X Walk 1 Width (in)	N/A	N/A	X Walk 2 Width (in)	N/A
	X Walk 1 Slope (%)	4.1		X Walk 2 Slope (%)	N/A
	X Walk 1 X Slope (%)	0.2		X Walk 2 X Slope (%)	N/A

N/A	Ramp inside XWalk1?	N/A	N/A	Ramp inside XWalk2?	N/A
	Road Slope (%)	0.2	N/A	Clear Space?	N/A
	Road X Slope (%)	4.1	N/A	Clear Space to XWalk (in)	N/A
N/A	Any Obstructions?	N/A	N/A	Storm Grate/Utility Hazard?	N/A
	Obstruction Type			Storm Grate/Utility Type	
		N/A			N/A
		Yes		Surface Condition? (G/P)	Good

**Remove & Replace Entire Ramp.**

**R304.5.3**

**\$ 1850.00**
