Access Compliance Report

Public Rights-of-Way

(Curb Ramps)

Intersection ID: 20129	Main Street: NATIONS_DR	Cross Street: NATIONS_FORD_RD	Location: SW
ADA ID: D338F31F6D24	Ramp Type: PerpDiag	Initial Pass/Fail: Fail	Overall Compliance: No
Severity Score: 21.25			
Codes/Mitigation Info/Possible Solution		Field Measurements/Component Compliance

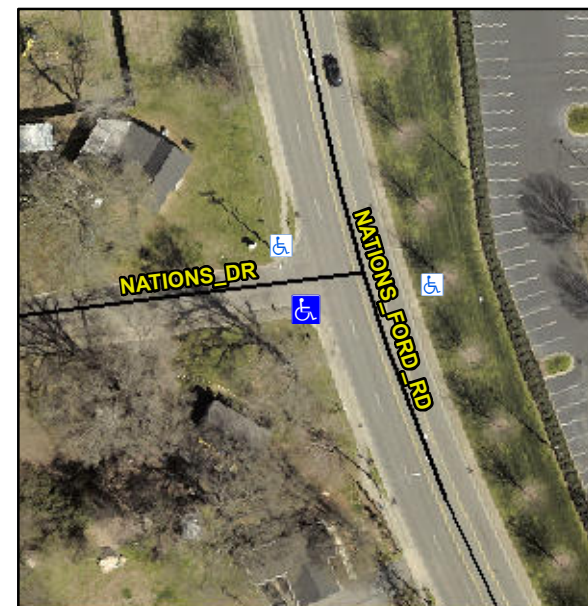
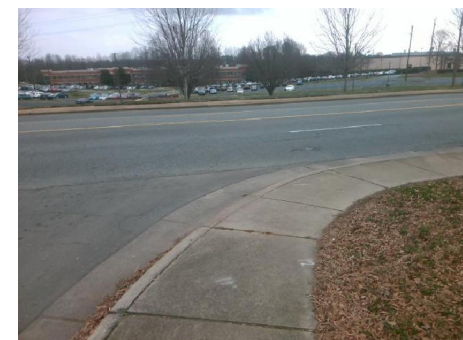
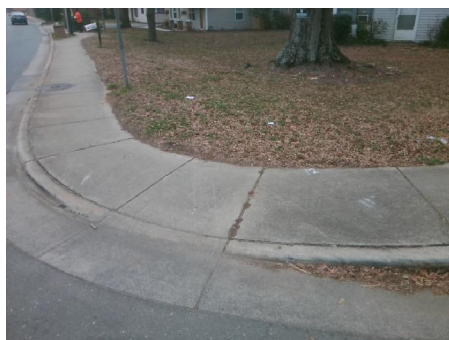
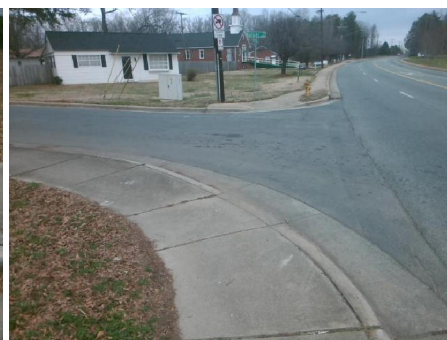
Compliance	Description	Data	Compliance	Description	Data
N/A	Ramp Length (in)	55.0	No	Ramp Slope (%)	8.7
No	Ramp Width (in)	37.0	Yes	Ramp XSlope (%)	1.6
N/A	Flare Type LT	N/A	N/A	Flare Type RT	N/A
N/A	Flare Slope LT (%)	N/A	N/A	Flare Slope RT (%)	N/A
N/A	Flare Traversable LT?	N/A	N/A	Flare Traversable RT?	N/A
N/A	Landing Length (in)	N/A	N/A	DWS Provided?	N/A
N/A	Landing Width (in)	N/A	N/A	DWS Contrast?	N/A
N/A	Landing Slope (%)	N/A	N/A	DWS Length (in)	N/A
N/A	Landing X Slope (%)	N/A	N/A	DWS Full Width?	N/A
N/A	Landing Curb? (Y/N)	N/A	N/A	DWS Offset (in)	N/A
N/A	Shared Landing?	N/A			
N/A	Gutter Ponding?	N/A	N/A	Gutter Slope (%)	N/A
N/A	Gutter Lip Ht (in)	N/A	N/A	Gutter X Slope (%)	N/A
N/A	Painted X Walk1?	No	N/A	Painted X Walk2?	No
	X Walk 1 Direction	To E		X Walk 2 Direction	To N
N/A	X Walk 1 Width (in)	N/A	N/A	X Walk 2 Width (in)	N/A
	X Walk 1 Slope (%)	0.7		X Walk 2 Slope (%)	1.3
	X Walk 1 X Slope (%)	0.4		X Walk 2 X Slope (%)	1.8

N/A	Ramp inside XWalk1?	N/A	N/A	Ramp inside XWalk2?	N/A
	Road Slope (%)	2.5	N/A	Clear Space?	N/A
	Road X Slope (%)	0.3	N/A	Clear Space to XWalk (in)	N/A
N/A	Any Obstructions?	N/A	N/A	Storm Grate/Utility Hazard?	N/A
	Obstruction Type			Storm Grate/Utility Type	
		N/A			N/A
		Yes		Surface Condition? (G/P)	Good

Possible Solutions:

Remove & Replace Curb Ramp With Two New Directional Ramps or Equivalent.

R304.5.1, R304.2.2
