# Access Compliance Report

## Public Rights-of-Way

### (Curb Ramps)

| Intersection ID: 17547 | Main Street: ALICIA_BRITTANY_LN | Cross Street: AMANDA_NICOLE_CT | Location: W |

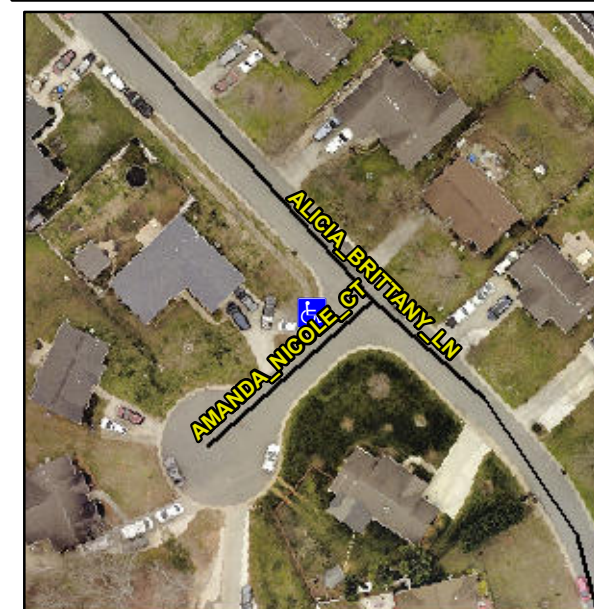
| ADA ID: D3403EBEEA3E | Ramp Type: PerpDiag | Initial Pass/Fail: Fail | Overall Compliance: No |
| Severity Score: 8.75 | | | |

**R304.5.1**

| Compliance | Description | Data | Compliance | Description | Data |
|---|---|---|---|---|---|
| No | Ramp Width (in) | 43.0 | Yes | Ramp XSlope (%) | 1.1 |

**Remove & Replace Curb Ramp With Two New Directional Ramps or Equivalent.**

Total Cost: \$ 3200.00
