# Access Compliance Report

## Public Rights-of-Way

### (Curb Ramps)

Intersection ID: N/A	Main Street: E_4TH_ST	Cross Street: S_DAVIDSON_ST	Location: N
ADA ID: D341F9D8DA8A	Ramp Type: Perp	Initial Pass/Fail: Fail	Overall Compliance: No
		Severity Score: 12.5	
Codes/Mitigation Info/Possible Solution		Field Measurements/Component Compliance

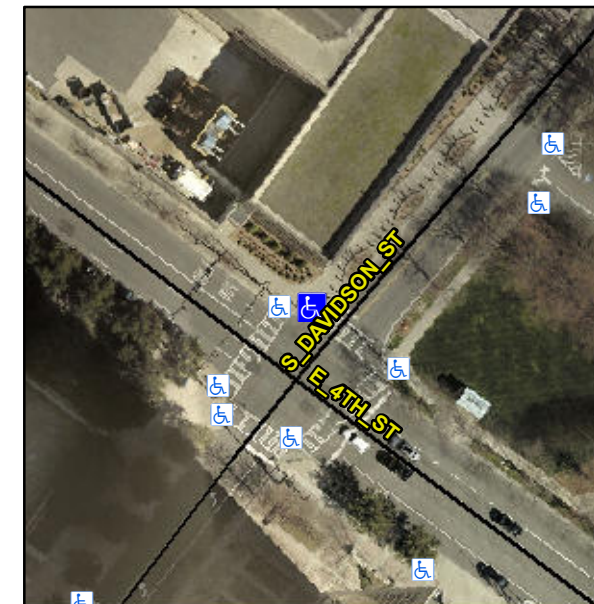
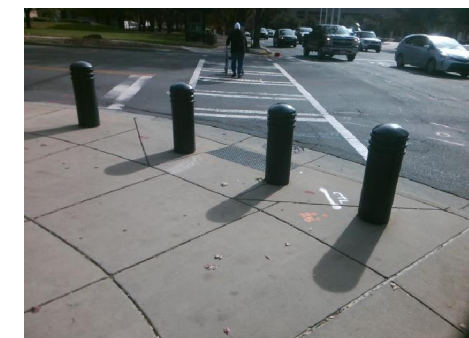
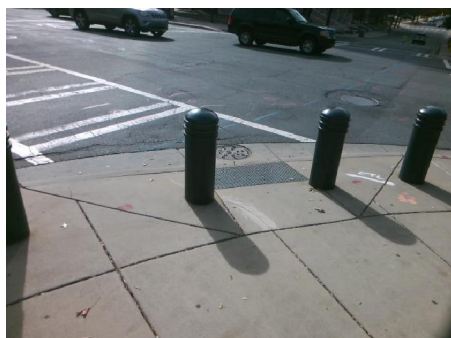
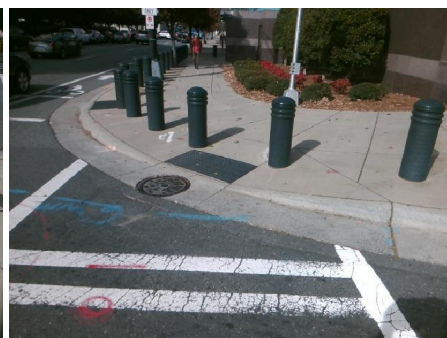
**R304.5.3**

Compliance	Description	Data	Compliance	Description	Data
N/A	Ramp Length (in)	61.0	Yes	Ramp Slope (%)	6.0
Yes	Ramp Width (in)	48.0	No	Ramp XSlope (%)	6.9
N/A	Flare Type LT	N/A	N/A	Flare Type RT	N/A
N/A	Flare Slope LT (%)	N/A	N/A	Flare Slope RT (%)	N/A
N/A	Flare Traversable LT?	No	N/A	Flare Traversable RT?	No
N/A	Landing Length (in)	N/A	N/A	DWS Provided?	N/A
N/A	Landing Width (in)	N/A	N/A	DWS Contrast?	N/A
N/A	Landing Slope (%)	N/A	N/A	DWS Length (in)	N/A
N/A	Landing X Slope (%)	N/A	N/A	DWS Full Width?	N/A
N/A	Landing Curb? (Y/N)	N/A	N/A	DWS Offset (in)	N/A
N/A	Shared Landing?	N/A			
N/A	Gutter Ponding?	N/A	N/A	Gutter Slope (%)	N/A
N/A	Gutter Lip Ht (in)	N/A	N/A	Gutter X Slope (%)	N/A
N/A	Painted X Walk1?	Yes	N/A	Painted X Walk2?	N/A
	X Walk 1 Direction	To SE		X Walk 2 Direction	N/A
N/A	X Walk 1 Width (in)	112.0	N/A	X Walk 2 Width (in)	N/A
	X Walk 1 Slope (%)	6.6		X Walk 2 Slope (%)	N/A
	X Walk 1 X Slope (%)	4.2		X Walk 2 X Slope (%)	N/A

N/A	Ramp inside XWalk1?	Yes	N/A	Ramp inside XWalk2?	N/A
	Road Slope (%)	N/A	N/A	Clear Space?	N/A
	Road X Slope (%)	N/A	N/A	Clear Space to XWalk (in)	N/A
N/A	Any Obstructions?	N/A	N/A	Storm Grate/Utility Hazard?	N/A
	Obstruction Type			Storm Grate/Utility Type	
		N/A			N/A
			Yes	Surface Condition? (G/P)	Good

**Remove & Replace Entire Ramp.**

\$ 1850.00
