Access Compliance Report

Public Rights-of-Way

(Curb Ramps)

Intersection ID: 9440	Main Street: BRADFORD_DR	Cross Street: EDGEWOOD_RD	Location: E
ADA ID: D3491506B9F7	Ramp Type: Perp	Initial Pass/Fail: Fail	Overall Compliance: No
Severity Score: 12.5			
Codes/Mitigation Info/Possible Solution		Field Measurements/Component Compliance

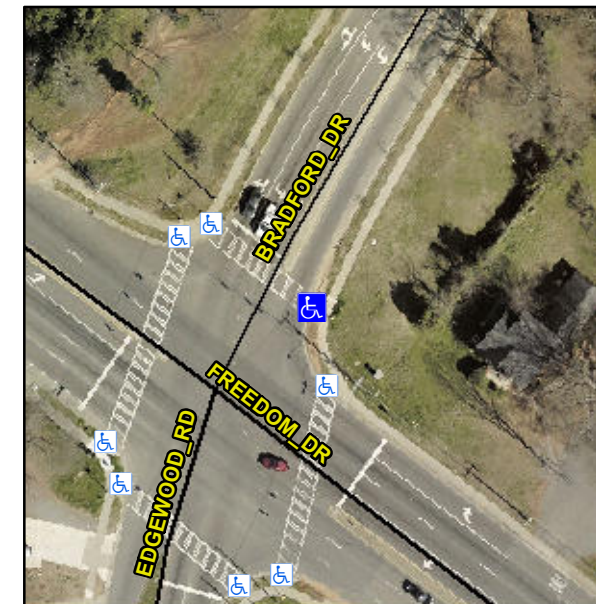
Not Found, R304.2.2

Compliance	Description	Data	Compliance	Description	Data
N/A	Ramp Length (in)	53.0	No	Ramp Slope (%)	9.9
Yes	Ramp Width (in)	48.0	Yes	Ramp XSlope (%)	0.5
N/A	Flare Type LT	N/A	N/A	Flare Type RT	N/A
N/A	Flare Slope LT (%)	N/A	N/A	Flare Slope RT (%)	N/A
N/A	Flare Traversable LT?	N/A	N/A	Flare Traversable RT?	N/A
N/A	Landing Length (in)	N/A	N/A	DWS Provided?	N/A
N/A	Landing Width (in)	N/A	N/A	DWS Contrast?	N/A
N/A	Landing Slope (%)	N/A	N/A	DWS Length (in)	N/A
N/A	Landing X Slope (%)	N/A	N/A	DWS Full Width?	N/A
N/A	Landing Curb? (Y/N)	N/A	N/A	DWS Offset (in)	N/A
N/A	Shared Landing?	N/A			
N/A	Gutter Ponding?	N/A	N/A	Gutter Slope (%)	N/A
N/A	Gutter Lip Ht (in)	N/A	N/A	Gutter X Slope (%)	N/A
N/A	Painted X Walk1?	Yes	N/A	Painted X Walk2?	N/A
	X Walk 1 Direction	To NW		X Walk 2 Direction	N/A
N/A	X Walk 1 Width (in)	116.0	N/A	X Walk 2 Width (in)	N/A
	X Walk 1 Slope (%)	2.9		X Walk 2 Slope (%)	N/A
	X Walk 1 X Slope (%)	0.0		X Walk 2 X Slope (%)	N/A

N/A	Ramp inside XWalk1?	Yes	N/A	Ramp inside XWalk2?	N/A
	Road Slope (%)	N/A	N/A	Clear Space?	N/A
	Road X Slope (%)	N/A	N/A	Clear Space to XWalk (in)	N/A
N/A	Any Obstructions?	N/A	N/A	Storm Grate/Utility Hazard?	N/A
	Obstruction Type			Storm Grate/Utility Type	
		N/A			N/A
		Yes		Surface Condition? (G/P)	Good

Possible Solutions:

Remove & Replace Entire Ramp.
