# Access Compliance Report

## Public Rights-of-Way

### (Curb Ramps)

Intersection ID: 32115	Main Street: COLE_MILL_RD	Cross Street: GALT_Y_LN	Location: E
ADA ID: D34EF40C6DA3	Ramp Type: BlendTrans1	Initial Pass/Fail: Fail	Overall Compliance: No
		Severity Score: 12.5

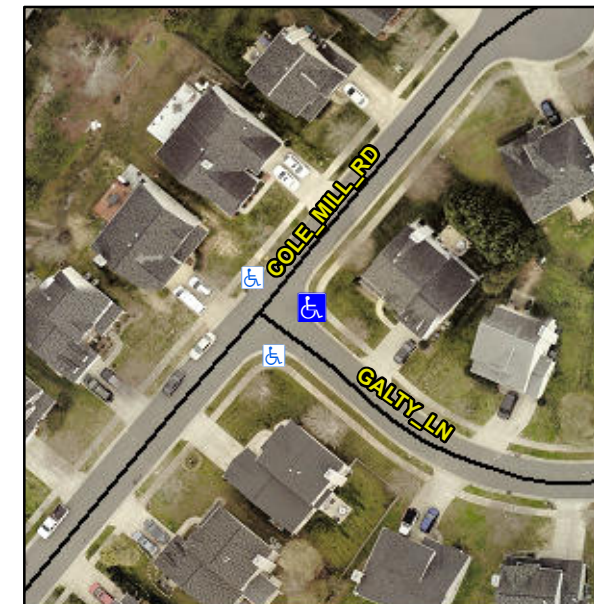
Compliance	Description	Data	Compliance	Description	Data
N/A	Ramp Length (in)	48.0	Yes	BlendTrans Slope (%)	4.7
Yes	Ramp Width (in)	50.0	No	BlendTrans XSlope (%)	6.9
N/A	Flare Type LT	N/A	N/A	Flare Type RT	N/A
N/A	Flare Slope LT (%)	N/A	N/A	Flare Slope RT (%)	N/A
N/A	Flare Traversable LT?	N/A	N/A	Flare Traversable RT?	N/A
N/A	Landing Length (in)	N/A	N/A	DWS Provided?	N/A
N/A	Landing Width (in)	N/A	N/A	DWS Contrast?	N/A
N/A	Landing Slope (%)	N/A	N/A	DWS Length (in)	N/A
N/A	Landing X Slope (%)	N/A	N/A	DWS Full Width?	N/A
N/A	Landing Curb? (Y/N)	N/A	N/A	DWS Offset (in)	N/A
N/A	Shared Landing?	N/A			
N/A	Gutter Ponding?	N/A	N/A	Gutter Slope (%)	N/A
N/A	Gutter Lip Ht (in)	N/A	N/A	Gutter X Slope (%)	N/A
N/A	Painted X Walk1?	No	N/A	Painted X Walk2?	No
	X Walk 1 Direction	To NW		X Walk 2 Direction	To SW
	X Walk 1 Width (in)	N/A		X Walk 2 Width (in)	N/A
	X Walk 1 Slope (%)	6.8		X Walk 2 Slope (%)	3.8
	X Walk 1 X Slope (%)	0.9		X Walk 2 X Slope (%)	3.9

N/A	Ramp inside XWalk1?	N/A	N/A	Ramp inside XWalk2?	N/A
	Road Slope (%)	0.9		Clear Space?	N/A
	Road X Slope (%)	5.1	N/A	Clear Space to XWalk (in)	N/A
N/A	Any Obstructions?	N/A	N/A	Storm Grate/Utility Hazard?	N/A
	Obstruction Type			Storm Grate/Utility Type	
		N/A			N/A
			Yes	Surface Condition? (G/P)	Good
			No	Curb Slope (%)	5.7

**Remove & Replace Curb Ramp With Two New Directional Ramps or Equivalent.**

**Not Found, R304.5.3**
