## Access Compliance Report Public Rights-of-Way (Curb Ramps)

Intersection ID: 21739
 Main Street:
 IMPERIAL\_CT
 Cross Street:
 ENGLAND\_ST
 Location:
 NE

ADA ID: D357589AC3EF
 Ramp Type:
 PerpDiag
 Initial Pass/Fail:
 Fail
 Overall Compliance:
 No
 Severity Score:
 25

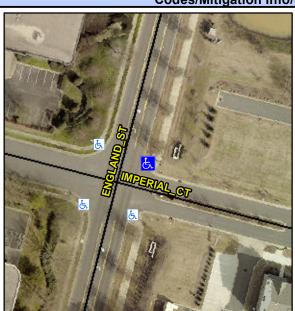
Field Measurements/Component Compliance					
Compliance Description		Data	Comp	liance Description	Data
N/A	Ramp Length (in)	92.0	Yes	Ramp Slope (%)	5.2
Yes	Ramp Width (in)	48.0	No	Ramp XSlope (%)	8.9
N/A	Flare Type LT	N/A	N/A	Flare Type RT	N/A
N/A	Flare Slope LT (%)	N/A	N/A	Flare Slope RT (%)	N/A
N/A	Flare Traversable LT?	N/A	N/A	Flare Traversable RT?	N/A
N/A	Landing Length (in)	N/A	N/A	DWS Provided?	N/A
N/A	Landing Width (in)	N/A	N/A	DWS Contrast?	N/A
N/A	Landing Slope (%)	N/A	N/A	DWS Length (in)	N/A
N/A	Landing X Slope (%)	N/A	N/A	DWS Full Width?	N/A
N/A	Landing Curb? (Y/N)	N/A	N/A	DWS Offset (in)	N/A
N/A	Shared Landing?	N/A			
N/A	Gutter Ponding?	N/A	N/A	Gutter Slope (%)	N/A
N/A	Gutter Lip Ht (in)	N/A	N/A	Gutter X Slope (%)	N/A
N/A	Painted X Walk1?	No	N/A	Painted X Walk2?	No
	X Walk 1 Direction	To NW		X Walk 2 Direction	To SW
N/A	X Walk 1 Width (in)	N/A	N/A	X Walk 2 Width (in)	N/A
	X Walk 1 Slope (%)	4.7		X Walk 2 Slope (%)	0.8

X Walk 1 X Slope (%)	3.3		X Walk 2 X Slope (%)	4.6
N/A	Ramp inside XWalk1?	N/A	N/A	Ramp inside XWalk2?	N/A
	Road Slope (%)	4.1	N/A	Clear Space?	N/A
	Road X Slope (%)	0.7	N/A	Clear Space to XWalk (in)	N/A
N/A	Any Obstructions?	N/A	N/A	Storm Grate/Utility Hazard?	N/A
	Obstruction Type		l	Storm Grate/Utility Type	
		N/A			N/A
			Yes	Surface Condition? (G/P)	Good

ENGLAND ST None IMPERIAL CT StopSign Possible Solutions:

Remove & Replace Curb Ramp With
Two New Directional Ramps or
Equivalent.
