Access Compliance Report

Public Rights-of-Way (Curb Ramps)

Intersection ID: 12695	Main Street: S_CALDWELL_ST	Cross Street: E TRADE ST	Location: E
ADA ID: D35C00B76095	Ramp Type: Combination2	Initial Pass/Fail: Fail	Overall Compliance: No
Severity Score: 13.75			
Codes/Mitigation Info/Possible Solution		Field Measurements/Component Compliance

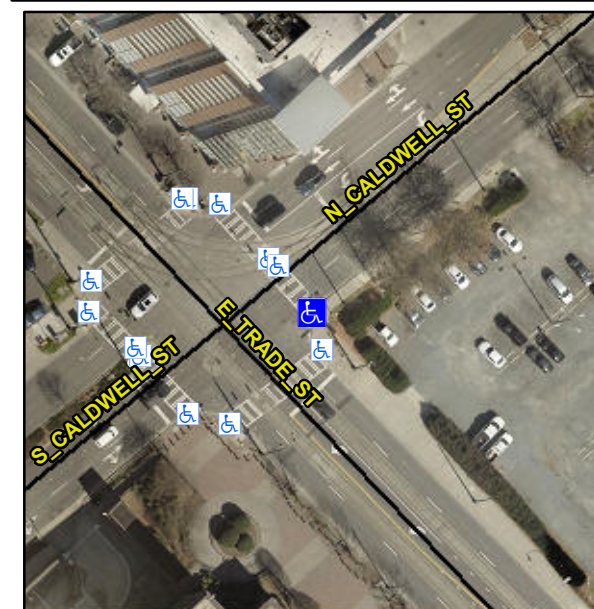
Not Found, R304.3.2, R304.5.3

Compliance	Description	Data	Compliance	Description	Data
N/A	Ramp Length LT (in)	54.0	N/A	Ramp Length RT (in)	N/A
Yes	Ramp Width LT (in)	49.0	N/A	Ramp Width RT (in)	N/A
No	Ramp Slope LT (%)	9.5	N/A	Ramp Slope RT (%)	N/A
No	Ramp XSlope LT (%)	2.9	N/A	Ramp XSlope RT (%)	N/A
N/A	Ramp Length (in)	25.0	Yes	Ramp Slope (%)	6.5
Yes	Ramp Width (in)	48.0	Yes	Ramp XSlope (%)	0.3
N/A	Flare Type LT	N/A	N/A	Flare Type RT	N/A
N/A	Flare Slope LT (%)	N/A	N/A	Flare Slope RT (%)	N/A
N/A	Flare Traversable LT?	N/A	N/A	Flare Traversable RT?	N/A
N/A	Landing Length (in)	N/A	N/A	DWS Provided?	N/A
N/A	Landing Width (in)	N/A	N/A	DWS Contrast?	N/A
N/A	Landing Slope (%)	N/A	N/A	DWS Length (in)	N/A
N/A	Landing X Slope (%)	N/A	N/A	DWS Full Width?	N/A
N/A	Landing Curb? (Y/N)	N/A	N/A	DWS Offset (in)	N/A
N/A	Shared Landing?	N/A			
N/A	Gutter Ponding?	N/A	N/A	Gutter Slope (%)	N/A
N/A	Gutter Lip Ht (in)	N/A	N/A	Gutter X Slope (%)	N/A
N/A	Painted X Walk1?	Yes	N/A	Painted X Walk2?	N/A

Remove & Replace Entire Ramp.

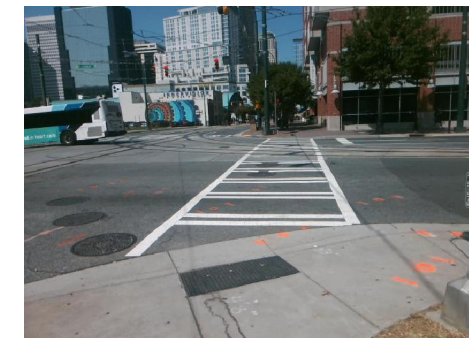
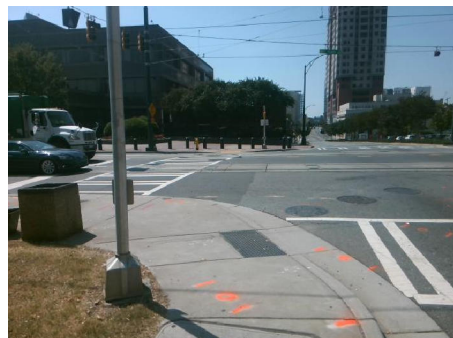
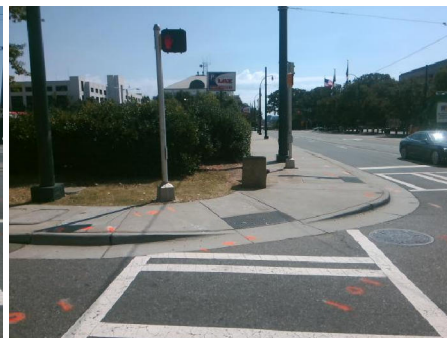
X Walk 1 Direction	To NW		X Walk 2 Direction	N/A
	X Walk 1 Width (in)	110.0		X Walk 2 Width (in)	N/A
	X Walk 1 Slope (%)	2.0		X Walk 2 Slope (%)	N/A
	X Walk 1 X Slope (%)	1.3		X Walk 2 X Slope (%)	N/A
N/A	Ramp inside XWalk1?	Yes	N/A	Ramp inside XWalk2?	N/A
	Road Slope (%)	N/A		Clear Space?	N/A
	Road X Slope (%)	N/A	N/A	Clear Space to XWalk (in)	N/A
			N/A	Any Obstruction?	N/A
				Obstruction Type	N/A
			N/A	Storm Grate/Utility Hazard?	N/A
				Storm Grate/Utility Type	N/A
					N/A
Yes	Surface Condition? (G/P)	Good			
	Curb Slope (%)	8.1
