Access Compliance Report

Public Rights-of-Way

(Curb Ramps)

Intersection ID: N/A	Main Street: TRYON_ST	Cross Street: BRONWIN_ST	Location: NE
ADA ID: D35CFB7FEC8B	Ramp Type: PerpDiag	Initial Pass/Fail: Fail	Overall Compliance: No
Codes/Mitigation Info/Possible Solution		Field Measurements/Component Compliance	
Severity Score: 33.75

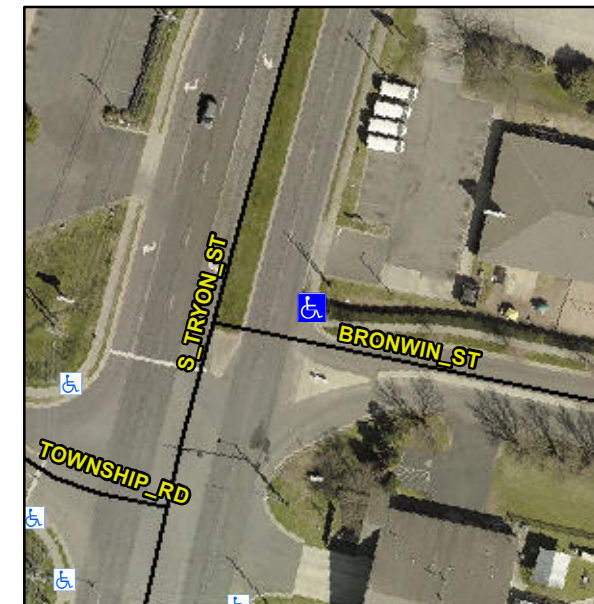
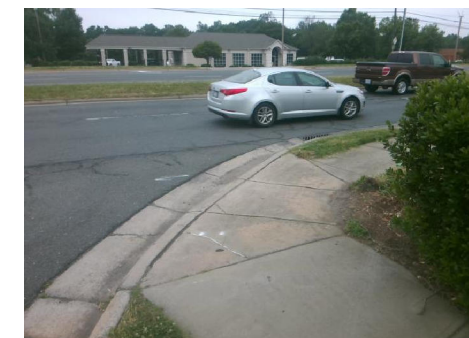
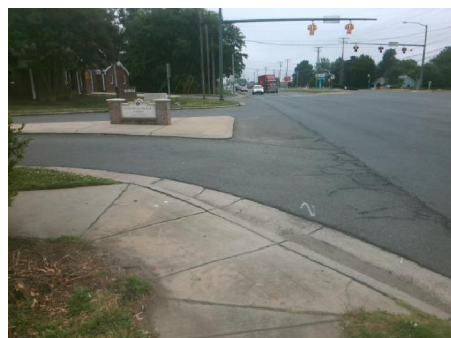
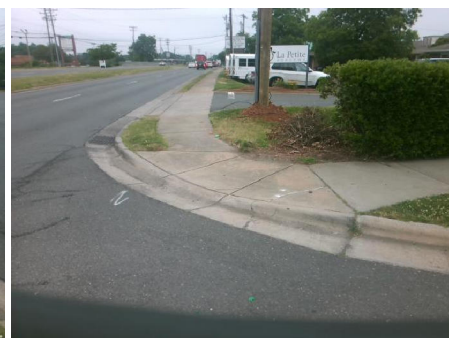
Not Found, R304.5.1, R304.2.2, R304.5.3

Compliance	Description	Data	Compliance	Description	Data
N/A	Ramp Length (in)	62.0	No	Ramp Slope (%)	8.5
No	Ramp Width (in)	44.0	No	Ramp XSlope (%)	6.0
N/A	Flare Type LT	N/A	N/A	Flare Type RT	N/A
N/A	Flare Slope LT (%)	N/A	N/A	Flare Slope RT (%)	N/A
N/A	Flare Traversable LT?	N/A	N/A	Flare Traversable RT?	N/A
N/A	Landing Length (in)	N/A	N/A	DWS Provided?	N/A
N/A	Landing Width (in)	N/A	N/A	DWS Contrast?	N/A
N/A	Landing Slope (%)	N/A	N/A	DWS Length (in)	N/A
N/A	Landing X Slope (%)	N/A	N/A	DWS Full Width?	N/A
N/A	Landing Curb? (Y/N)	N/A	N/A	DWS Offset (in)	N/A
N/A	Shared Landing?	N/A			
N/A	Gutter Ponding?	N/A	N/A	Gutter Slope (%)	N/A
N/A	Gutter Lip Ht (in)	N/A	N/A	Gutter X Slope (%)	N/A
N/A	Painted X Walk1?	No	N/A	Painted X Walk2?	No
	X Walk 1 Direction	To W		X Walk 2 Direction	To S
N/A	X Walk 1 Width (in)	N/A	N/A	X Walk 2 Width (in)	N/A
	X Walk 1 Slope (%)	2.6		X Walk 2 Slope (%)	0.5
	X Walk 1 X Slope (%)	0.2		X Walk 2 X Slope (%)	2.7

N/A	Ramp inside XWalk1?	N/A	N/A	Ramp inside XWalk2?	N/A
	Road Slope (%)	0.4	N/A	Clear Space?	N/A
	Road X Slope (%)	0.0	N/A	Clear Space to XWalk (in)	N/A
N/A	Any Obstructions?	N/A	N/A	Storm Grate/Utility Hazard?	N/A
	Obstruction Type			Storm Grate/Utility Type	
		N/A			N/A
			Yes	Surface Condition? (G/P)	Good

Remove & Replace Curb Ramp With Two New Directional Ramps or Equivalent.
