Access Compliance Report

Public Rights-of-Way

(Curb Ramps)

Intersection ID: 2489	Main Street: CLARKE_CREEK_PY	Cross Street: HIGHLAND_CREEK_PY	Location:	E
ADA ID: D35DDC2545BD	Ramp Type: PerpDiag	Initial Pass/Fail: Fail	Overall Compliance: No	Severity Score: 10
Codes/Mitigation Info/Possible Solution		Field Measurements/Component Compliance

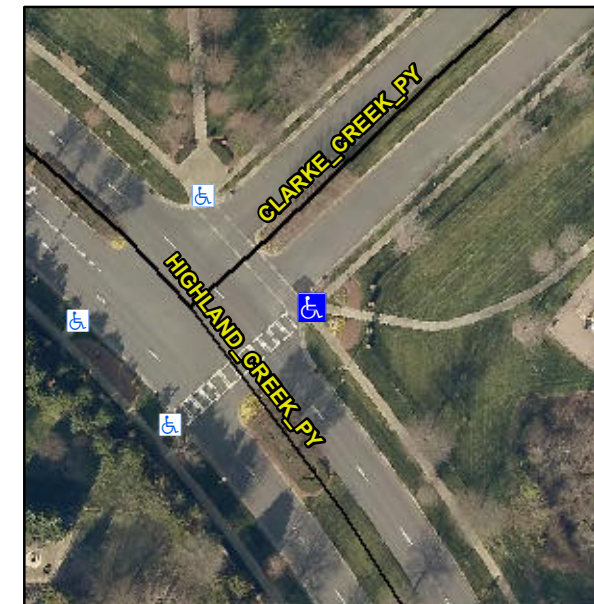
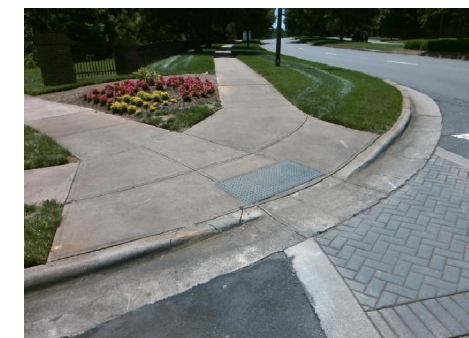
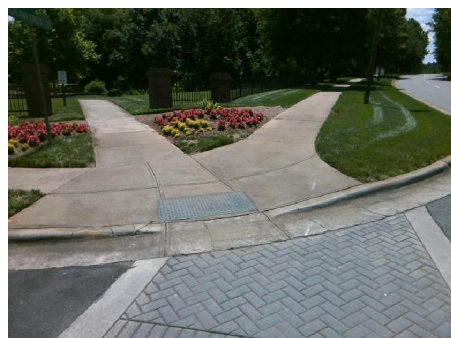
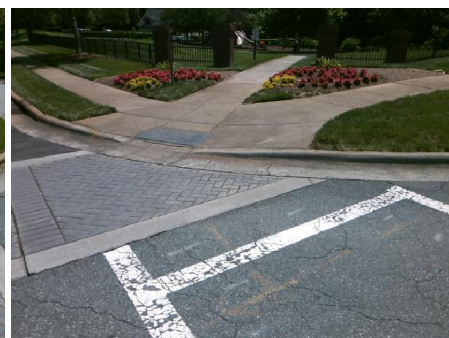
PROW/ADA:

R304.5.1, R304.5.3

Compliance	Description	Data	Compliance	Description	Data
N/A	Ramp Length (in)	46.0	Yes	Ramp Slope (%)	5.2
No	Ramp Width (in)	38.0	No	Ramp XSlope (%)	2.5
N/A	Flare Type LT	N/A	N/A	Flare Type RT	N/A
N/A	Flare Slope LT (%)	N/A	N/A	Flare Slope RT (%)	N/A
N/A	Flare Traversable LT?	N/A	N/A	Flare Traversable RT?	N/A
N/A	Landing Length (in)	N/A	N/A	DWS Provided?	N/A
N/A	Landing Width (in)	N/A	N/A	DWS Contrast?	N/A
N/A	Landing Slope (%)	N/A	N/A	DWS Length (in)	N/A
N/A	Landing X Slope (%)	N/A	N/A	DWS Full Width?	N/A
N/A	Landing Curb? (Y/N)	N/A	N/A	DWS Offset (in)	N/A
N/A	Shared Landing?	N/A			
N/A	Gutter Ponding?	N/A	N/A	Gutter Slope (%)	N/A
N/A	Gutter Lip Ht (in)	N/A	N/A	Gutter X Slope (%)	N/A
N/A	Painted X Walk1?	Yes	N/A	Painted X Walk2?	Yes
	X Walk 1 Direction	To NW		X Walk 2 Direction	To SW
N/A	X Walk 1 Width (in)	94.0	N/A	X Walk 2 Width (in)	108.0
	X Walk 1 Slope (%)	0.9		X Walk 2 Slope (%)	3.5
	X Walk 1 X Slope (%)	3.5		X Walk 2 X Slope (%)	0.1

N/A	Ramp inside XWalk1?	Yes	N/A	Ramp inside XWalk2?	Yes
	Road Slope (%)	3.1	N/A	Clear Space?	N/A
	Road X Slope (%)	1.0	N/A	Clear Space to XWalk (in)	N/A
N/A	Any Obstructions?	N/A	N/A	Storm Grate/Utility Hazard?	N/A
	Obstruction Type			Storm Grate/Utility Type	
		N/A			N/A
			Yes	Surface Condition? (G/P)	Good

Possible Solutions:

Remove & Replace Curb Ramp With Two New Directional Ramps or Equivalent.
