# Access Compliance Report

## Public Rights-of-Way

### (Curb Ramps)

Intersection ID: 16670	Main Street: BEVERLY_DR	Cross Street: PROVIDENCE_RD	Location: NW
ADA ID: D36018F21F17	Ramp Type: Perp	Initial Pass/Fail: Fail	Overall Compliance: No
Severity Score: 17.5			
Codes/Mitigation Info/Possible Solution		Field Measurements/Component Compliance

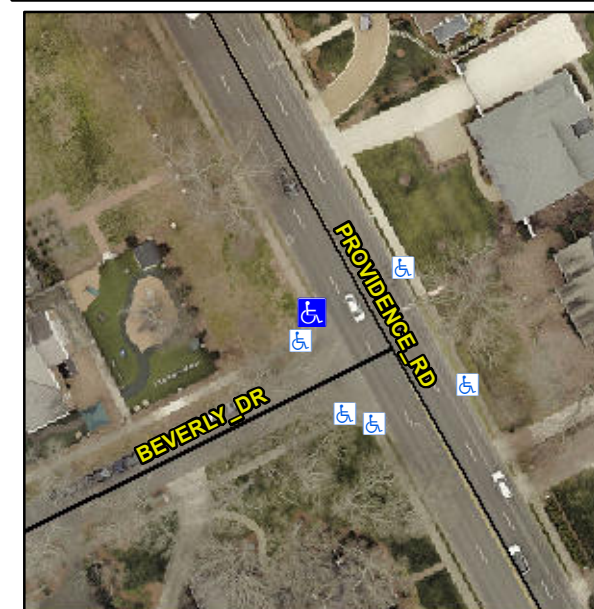
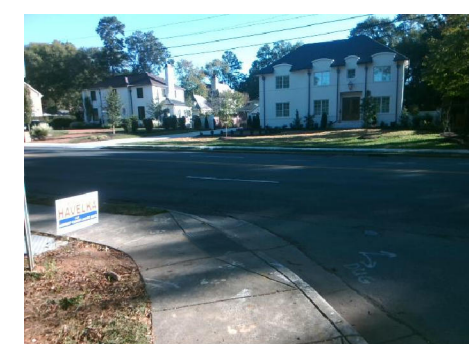
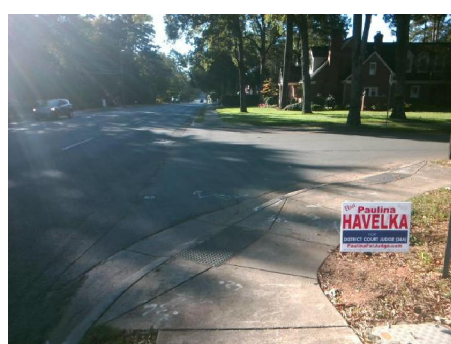
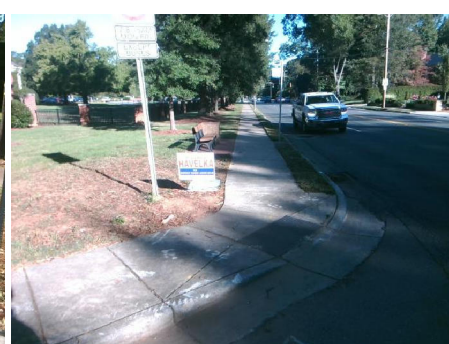
**Not Found, R304.5.1**

Compliance	Description	Data	Compliance	Description	Data
N/A	Ramp Length (in)	62.0	Yes	Ramp Slope (%)	5.4
No	Ramp Width (in)	34.0	Yes	Ramp XSlope (%)	0.1
N/A	Flare Type LT	N/A	N/A	Flare Type RT	N/A
N/A	Flare Slope LT (%)	N/A	N/A	Flare Slope RT (%)	N/A
N/A	Flare Traversable LT?	N/A	N/A	Flare Traversable RT?	N/A
N/A	Landing Length (in)	N/A	N/A	DWS Provided?	N/A
N/A	Landing Width (in)	N/A	N/A	DWS Contrast?	N/A
N/A	Landing Slope (%)	N/A	N/A	DWS Length (in)	N/A
N/A	Landing X Slope (%)	N/A	N/A	DWS Full Width?	N/A
N/A	Landing Curb? (Y/N)	N/A	N/A	DWS Offset (in)	N/A
N/A	Shared Landing?	N/A			
N/A	Gutter Ponding?	N/A	N/A	Gutter Slope (%)	N/A
N/A	Gutter Lip Ht (in)	N/A	N/A	Gutter X Slope (%)	N/A
N/A	Painted X Walk1?	No	N/A	Painted X Walk2?	N/A
	X Walk 1 Direction	To NE		X Walk 2 Direction	N/A
N/A	X Walk 1 Width (in)	N/A	N/A	X Walk 2 Width (in)	N/A
	X Walk 1 Slope (%)	4.2		X Walk 2 Slope (%)	N/A
	X Walk 1 X Slope (%)	1.9		X Walk 2 X Slope (%)	N/A

N/A	Ramp inside XWalk1?	N/A	N/A	Ramp inside XWalk2?	N/A
	Road Slope (%)	N/A	N/A	Clear Space?	N/A
	Road X Slope (%)	N/A	N/A	Clear Space to XWalk (in)	N/A
N/A	Any Obstructions?	N/A	N/A	Storm Grate/Utility Hazard?	N/A
	Obstruction Type			Storm Grate/Utility Type	
		N/A			N/A
		Yes		Surface Condition? (G/P)	Good

**Remove & Replace Entire Ramp.**

Total Cost: \$ 1850.00
