Access Compliance Report

Public Rights-of-Way

(Curb Ramps)

Intersection ID: 50193	Main Street: CHARNDON_VILLAGE_CT	Cross Street: BOYCE_RD	Location: NE
ADA ID: D36710D0EEB6	Ramp Type: Directional1	Initial Pass/Fail: Fail	Overall Compliance: No
Codes/Mitigation Info/Possible Solution		Field Measurements/Component Compliance	
Severity Score: 1.25

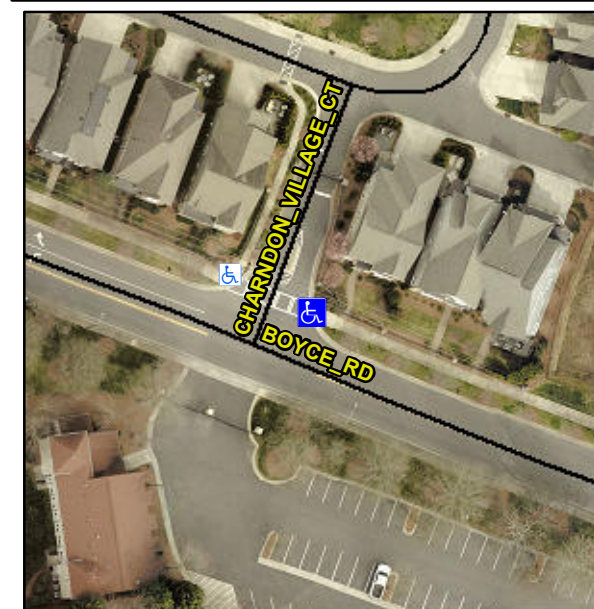
Compliance	Description	Data	Compliance	Description	Data
N/A	Ramp Length (in)	105.0	N/A	Grade Break?	N/A
Yes	Ramp Width (in)	72.0	N/A	Grade Break Slope (%)	0.0
Yes	Ramp Slope (%)	0.8	N/A	Grade Break XSlope (%)	0.0
No	Ramp XSlope (%)	3.0			
N/A	Flare Type LT	N/A	N/A	Flare Type RT	N/A
N/A	Flare Slope LT (%)	N/A	N/A	Flare Slope RT (%)	0.0
N/A	Flare Traversable LT?	N/A	N/A	Flare Traversable RT?	N/A
N/A	Landing Length (in)	0.0	N/A	DWS Provided?	N/A
N/A	Landing Width (in)	0.0	N/A	DWS Contrast?	N/A
N/A	Landing Slope (%)	0.0	N/A	DWS Length (in)	N/A
N/A	Landing X Slope (%)	0.0	N/A	DWS Full Width?	N/A
N/A	Landing Curb? (Y/N)	N/A	N/A	DWS Offset LT (in)	N/A
N/A	Shared Landing?	N/A	N/A	DWS Offset RT (in)	N/A
N/A	Gutter Ponding?	0.0	N/A	Gutter Slope (%)	N/A
N/A	Gutter Lip Ht (in)	0.0	N/A	Gutter X Slope (%)	N/A
N/A	Painted X Walk1?	Yes		Road Slope (%)	3.3
	X Walk 1 Direction	To W		Road X Slope (%)	1.7
	X Walk 1 Width (in)	88.0		Clear Space?	N/A

X Walk 1 Slope (%)	3.3	N/A	Clear Space to XWalk (in)	N/A
	X Walk 1 X Slope (%)	1.7	N/A	Storm Grate/Utility Hazard?	N/A
N/A	Ramp inside XWalk1?	Yes		Storm Grate/Utility Type	
N/A	Any Obstructions?	N/A			N/A
	Obstruction Type		Yes	Surface Condition? (G/P)	Good
			N/A	Curb Slope (%)	3.7

Possible Solutions:

Remove & Replace Entire Ramp.

R304.5.3
