Access Compliance Report

Public Rights-of-Way

(Curb Ramps)

Intersection ID: 12867	Main Street: ENFIELD_RD	Cross Street: N/A	Location: SE
ADA ID: D36826499BE2	Ramp Type: Perp	Initial Pass/Fail: Fail	Overall Compliance: No
Severity Score: 48.75			
Codes/Mitigation Info/Possible Solution		Field Measurements/Component Compliance

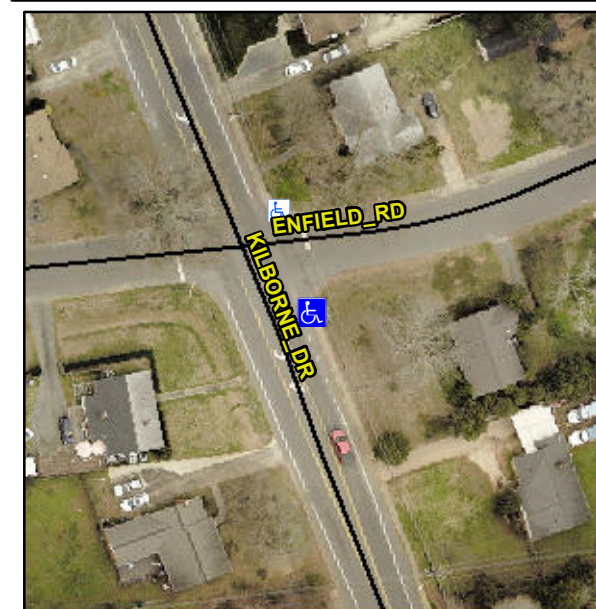
Not Found, R304.5.1, R304.2.2, R304.5.3

Compliance	Description	Data	Compliance	Description	Data
N/A	Ramp Length (in)	23.0	No	Ramp Slope (%)	8.7
No	Ramp Width (in)	24.0	No	Ramp XSlope (%)	2.1
N/A	Flare Type LT	N/A	N/A	Flare Type RT	N/A
N/A	Flare Slope LT (%)	N/A	N/A	Flare Slope RT (%)	N/A
N/A	Flare Traversable LT?	N/A	N/A	Flare Traversable RT?	N/A
N/A	Landing Length (in)	N/A	N/A	DWS Provided?	N/A
N/A	Landing Width (in)	N/A	N/A	DWS Contrast?	N/A
N/A	Landing Slope (%)	N/A	N/A	DWS Length (in)	N/A
N/A	Landing X Slope (%)	N/A	N/A	DWS Full Width?	N/A
N/A	Landing Curb? (Y/N)	N/A	N/A	DWS Offset (in)	N/A
N/A	Shared Landing?	N/A			
N/A	Gutter Ponding?	N/A	N/A	Gutter Slope (%)	N/A
N/A	Gutter Lip Ht (in)	N/A	N/A	Gutter X Slope (%)	N/A
N/A	Painted X Walk1?	No	N/A	Painted X Walk2?	N/A
	X Walk 1 Direction	To N		X Walk 2 Direction	N/A
N/A	X Walk 1 Width (in)	N/A	N/A	X Walk 2 Width (in)	N/A
	X Walk 1 Slope (%)	0.0		X Walk 2 Slope (%)	N/A
	X Walk 1 X Slope (%)	1.3		X Walk 2 X Slope (%)	N/A

N/A	Ramp inside XWalk1?	N/A	N/A	Ramp inside XWalk2?	N/A
	Road Slope (%)	N/A	N/A	Clear Space?	N/A
	Road X Slope (%)	N/A	N/A	Clear Space to XWalk (in)	N/A
N/A	Any Obstructions?	N/A	N/A	Storm Grate/Utility Hazard?	N/A
	Obstruction Type			Storm Grate/Utility Type	
		N/A			N/A
			Yes	Surface Condition? (G/P)	Good

Remove & Replace Entire Ramp.
