# Access Compliance Report

## Public Rights-of-Way

### (Curb Ramps)

| Intersection ID: 30456 | Main Street: STEELE_MEADOW_RD | Cross Street: WALLAND_LN | Location: SW |

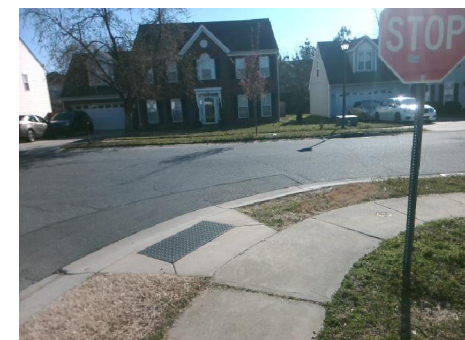
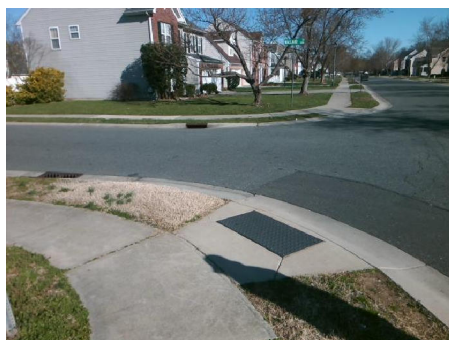
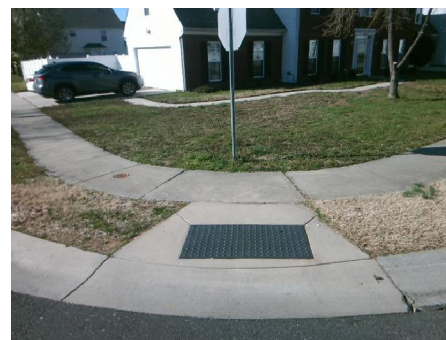
| ADA ID: D36BB249EF29 | Ramp Type: BlendTrans2 | Initial Pass/Fail: Pass | Overall Compliance: No |
| | | Severity Score: 2.5 | |

**Not Found, R305.1.4, R305.2**

| Compliance | Description | Data | Compliance | Description | Data |
|---|---|---|---|---|---|
| N/A | Landing X Slope (%) | N/A | No | DWS Full Width? | No |
| N/A | Landing Curb? (Y/N) | No | No | DWS Offset (in) | 5.0 |
| | | | No | Curb Slope (%) | 25.5 |

**Remove & Replace Curb Ramp With Two New Directional Ramps or Equivalent.**

Total Cost: \$ 3200.00
