# Access Compliance Report

## Public Rights-of-Way

### (Curb Ramps)

| Intersection ID: 52698 | Main Street: JOSEPHINE_CT | Cross Street: MECKLENBURG_AV | Location: SW |

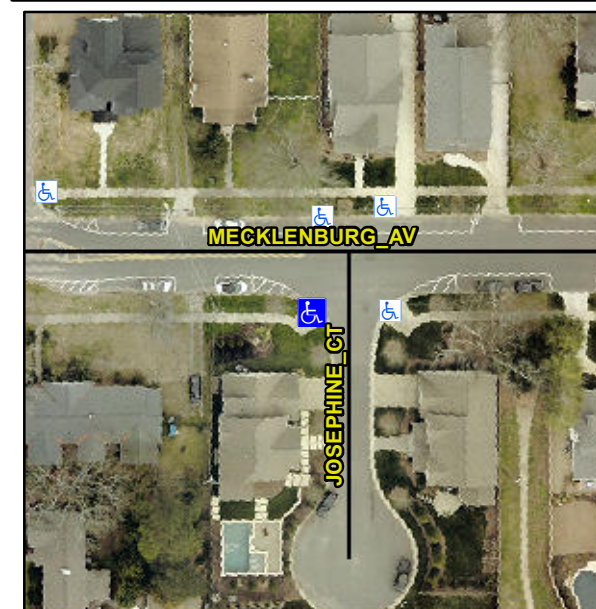
| ADA ID: D373C5F6617C | Ramp Type: PerpDiag | Initial Pass/Fail: Pass | Overall Compliance: No |

**Not Found, R304.5.3**

| Compliance | Description | Data | Compliance | Description | Data |
|---|---|---|---|---|---|
| No | Landing X Slope (%) | 2.8 | Yes | DWS Full Width? | Yes |

**Remove & Replace Curb Ramp With Two New Directional Ramps or Equivalent.**

Total Cost: \$ 3200.00

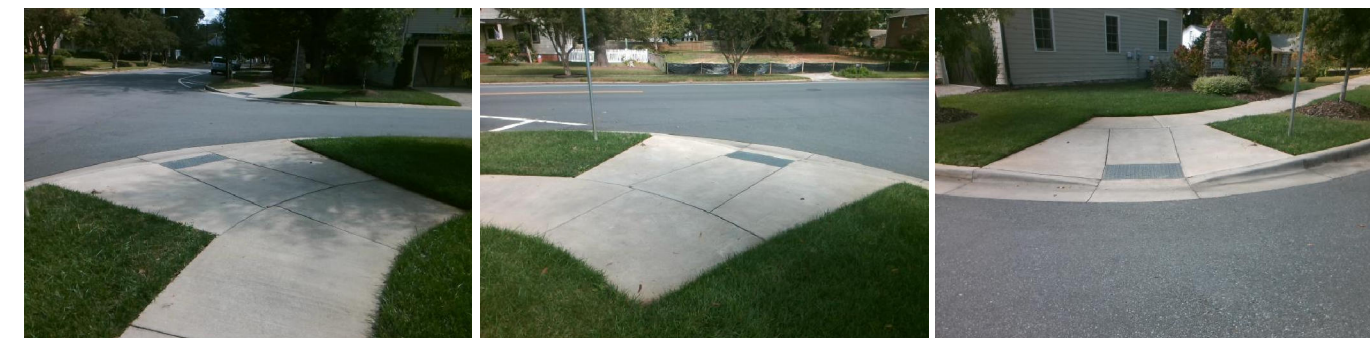
Street 1 Name JOSEPHINE CT  
 Stop Condition-Street 2 StopSign  
 Street 2 Name MECKLENBURG AV  
 Stop Condition-Street 1 None
