Access Compliance Report

Public Rights-of-Way

(Curb Ramps)

Intersection ID: 42734	Main Street: GRIER_SPRINGS_LN	Cross Street: CALDWELL_FOREST_DR	Location: S
ADA ID: D3781439A1D1	Ramp Type: PerpDiag	Initial Pass/Fail: Fail	Overall Compliance: No
Codes/Mitigation Info/Possible Solution		Field Measurements/Component Compliance

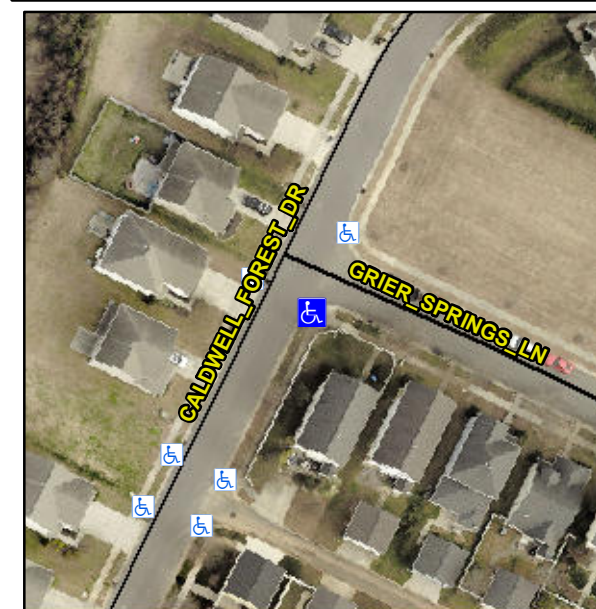
Not Found, R304.5.1, R304.2.2, R304.5.3

Compliance	Description	Data	Compliance	Description	Data
N/A	Ramp Length (in)	54.0	No	Ramp Slope (%)	8.5
No	Ramp Width (in)	32.0	No	Ramp XSlope (%)	5.0
N/A	Flare Type LT	N/A	N/A	Flare Type RT	N/A
N/A	Flare Slope LT (%)	N/A	N/A	Flare Slope RT (%)	N/A
N/A	Flare Traversable LT?	N/A	N/A	Flare Traversable RT?	N/A
N/A	Landing Length (in)	N/A	N/A	DWS Provided?	N/A
N/A	Landing Width (in)	N/A	N/A	DWS Contrast?	N/A
N/A	Landing Slope (%)	N/A	N/A	DWS Length (in)	N/A
N/A	Landing X Slope (%)	N/A	N/A	DWS Full Width?	N/A
N/A	Landing Curb? (Y/N)	N/A	N/A	DWS Offset (in)	N/A
N/A	Shared Landing?	N/A			
N/A	Gutter Ponding?	N/A	N/A	Gutter Slope (%)	N/A
N/A	Gutter Lip Ht (in)	N/A	N/A	Gutter X Slope (%)	N/A
N/A	Painted X Walk1?	No	N/A	Painted X Walk2?	No
	X Walk 1 Direction	To N		X Walk 2 Direction	To W
N/A	X Walk 1 Width (in)	N/A	N/A	X Walk 2 Width (in)	N/A
	X Walk 1 Slope (%)	3.7		X Walk 2 Slope (%)	0.7
	X Walk 1 X Slope (%)	5.2		X Walk 2 X Slope (%)	3.3

N/A	Ramp inside XWalk1?	N/A	N/A	Ramp inside XWalk2?	N/A
	Road Slope (%)	2.9	N/A	Clear Space?	N/A
	Road X Slope (%)	1.1	N/A	Clear Space to XWalk (in)	N/A
N/A	Any Obstructions?	N/A	N/A	Storm Grate/Utility Hazard?	N/A
	Obstruction Type			Storm Grate/Utility Type	
		N/A			N/A
			Yes	Surface Condition? (G/P)	Good

Remove & Replace Curb Ramp With Two New Directional Ramps or Equivalent.
