Access Compliance Report

Public Rights-of-Way

(Curb Ramps)

Intersection ID: 21509	Main Street: COVEDALE_DR	Cross Street: SARDIS_RD_NORTH	Location: NW
ADA ID: D3803702D9DC	Ramp Type: PerpDiag	Initial Pass/Fail: Fail	Overall Compliance: No
		Severity Score: 25

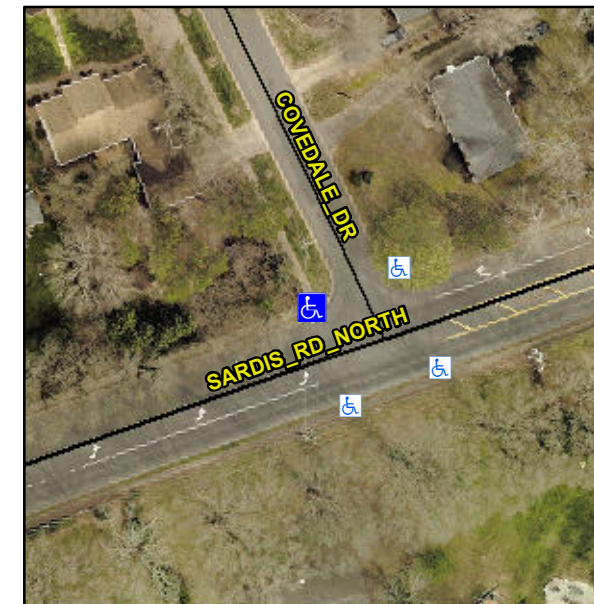
Not Found, R304.2.2

Compliance	Description	Data	Compliance	Description	Data
N/A	Ramp Length (in)	72.0	No	Ramp Slope (%)	13.6
Yes	Ramp Width (in)	48.0	Yes	Ramp XSlope (%)	0.6
N/A	Flare Type LT	N/A	N/A	Flare Type RT	N/A
N/A	Flare Slope LT (%)	N/A	N/A	Flare Slope RT (%)	N/A
N/A	Flare Traversable LT?	N/A	N/A	Flare Traversable RT?	N/A
N/A	Landing Length (in)	N/A	N/A	DWS Provided?	N/A
N/A	Landing Width (in)	N/A	N/A	DWS Contrast?	N/A
N/A	Landing Slope (%)	N/A	N/A	DWS Length (in)	N/A
N/A	Landing X Slope (%)	N/A	N/A	DWS Full Width?	N/A
N/A	Landing Curb? (Y/N)	N/A	N/A	DWS Offset (in)	N/A
N/A	Shared Landing?	N/A			
N/A	Gutter Ponding?	N/A	N/A	Gutter Slope (%)	N/A
N/A	Gutter Lip Ht (in)	N/A	N/A	Gutter X Slope (%)	N/A
N/A	Painted X Walk1?	No	N/A	Painted X Walk2?	No
	X Walk 1 Direction	To S		X Walk 2 Direction	To E
N/A	X Walk 1 Width (in)	N/A	N/A	X Walk 2 Width (in)	N/A
	X Walk 1 Slope (%)	3.5		X Walk 2 Slope (%)	1.3
	X Walk 1 X Slope (%)	2.3		X Walk 2 X Slope (%)	0.8

Remove & Replace Curb Ramp With Two New Directional Ramps or Equivalent.

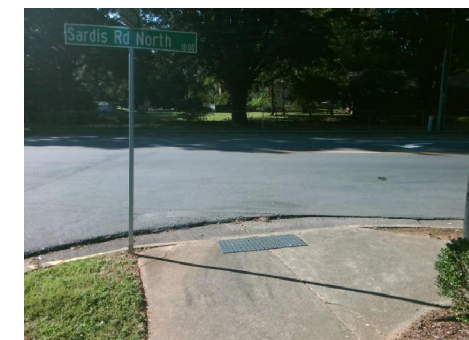
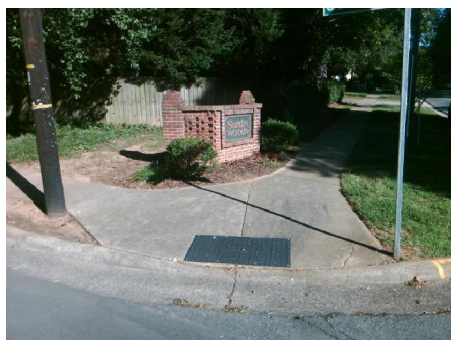
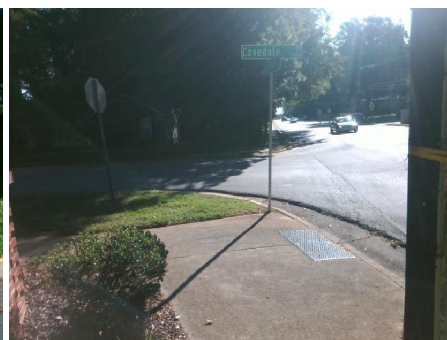
N/A	Ramp inside XWalk1?	N/A	N/A	Ramp inside XWalk2?	N/A
	Road Slope (%)	1.4	N/A	Clear Space?	N/A
	Road X Slope (%)	2.8	N/A	Clear Space to XWalk (in)	N/A
N/A	Any Obstructions?	N/A	N/A	Storm Grate/Utility Hazard?	N/A
	Obstruction Type			Storm Grate/Utility Type	
		N/A			N/A
			Yes	Surface Condition? (G/P)	Good
