Access Compliance Report

Public Rights-of-Way

(Curb Ramps)

Intersection ID: 9381	Main Street: GLENWOOD_DR	Cross Street: PLAINVIEW_RD	Location:	N
ADA ID: D387FEF898C7	Ramp Type: Perp	Initial Pass/Fail: Fail	Overall Compliance: No	Severity Score: 8.75
Codes/Mitigation Info/Possible Solution		Field Measurements/Component Compliance

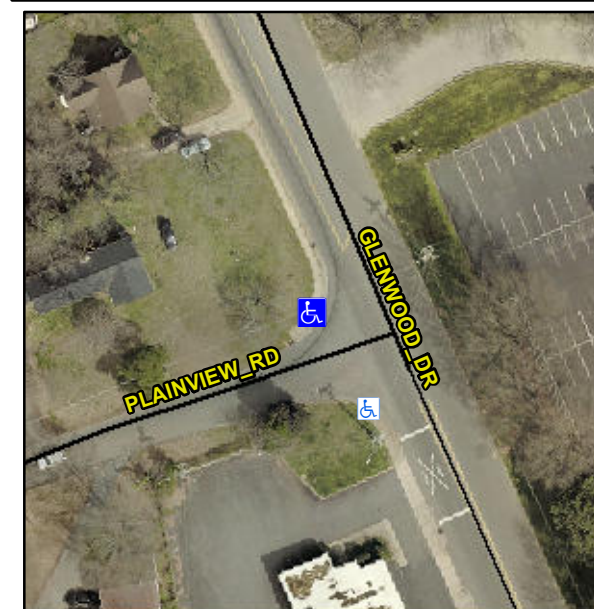
Compliance	Description	Data	Compliance	Description	Data
N/A	Ramp Length (in)	62.0	Yes	Ramp Slope (%)	8.0
No	Ramp Width (in)	42.0	Yes	Ramp XSlope (%)	2.0
N/A	Flare Type LT	N/A	N/A	Flare Type RT	N/A
N/A	Flare Slope LT (%)	N/A	N/A	Flare Slope RT (%)	N/A
N/A	Flare Traversable LT?	N/A	N/A	Flare Traversable RT?	N/A
N/A	Landing Length (in)	N/A	N/A	DWS Provided?	N/A
N/A	Landing Width (in)	N/A	N/A	DWS Contrast?	N/A
N/A	Landing Slope (%)	N/A	N/A	DWS Length (in)	N/A
N/A	Landing X Slope (%)	N/A	N/A	DWS Full Width?	N/A
N/A	Landing Curb? (Y/N)	N/A	N/A	DWS Offset (in)	N/A
N/A	Shared Landing?	N/A			
N/A	Gutter Ponding?	N/A	N/A	Gutter Slope (%)	N/A
N/A	Gutter Lip Ht (in)	0.5	N/A	Gutter X Slope (%)	N/A
N/A	Painted X Walk1?	No	N/A	Painted X Walk2?	N/A
	X Walk 1 Direction	To S		X Walk 2 Direction	N/A
N/A	X Walk 1 Width (in)	N/A	N/A	X Walk 2 Width (in)	N/A
	X Walk 1 Slope (%)	5.2		X Walk 2 Slope (%)	N/A
	X Walk 1 X Slope (%)	3.8		X Walk 2 X Slope (%)	N/A

N/A	Ramp inside XWalk1?	N/A	N/A	Ramp inside XWalk2?	N/A
	Road Slope (%)	N/A	N/A	Clear Space?	N/A
	Road X Slope (%)	N/A	N/A	Clear Space to XWalk (in)	N/A
N/A	Any Obstructions?	N/A	N/A	Storm Grate/Utility Hazard?	N/A
	Obstruction Type			Storm Grate/Utility Type	
		N/A			N/A
			Yes	Surface Condition? (G/P)	Good

Possible Solutions:

Remove & Replace Entire Ramp.

R304.5.1

Total Cost: \$ 1850.00
