# Access Compliance Report

## Public Rights-of-Way

### (Curb Ramps)

Intersection ID: 23162	Main Street: SHARON_RD_WEST	Cross Street: SOUTH_BV	Location: S
ADA ID: D38D5180B7E7	Ramp Type: Perp	Initial Pass/Fail: Fail	Overall Compliance: No
		Severity Score: 22.5

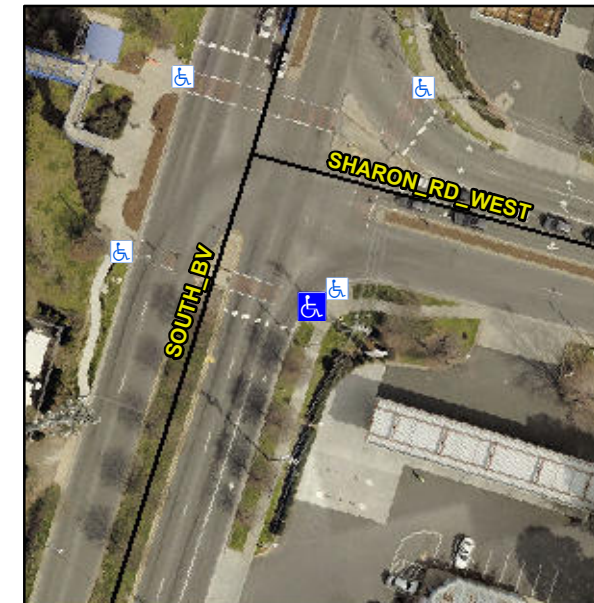
**Not Found, R304.5.1, R304.2.2**

Compliance	Description	Data	Compliance	Description	Data
N/A	Ramp Length (in)	95.0	No	Ramp Slope (%)	10.8
No	Ramp Width (in)	36.5	Yes	Ramp XSlope (%)	2.8
N/A	Flare Type LT	N/A	N/A	Flare Type RT	N/A
N/A	Flare Slope LT (%)	N/A	N/A	Flare Slope RT (%)	N/A
N/A	Flare Traversable LT?	N/A	N/A	Flare Traversable RT?	N/A
N/A	Landing Length (in)	N/A	N/A	DWS Provided?	N/A
N/A	Landing Width (in)	N/A	N/A	DWS Contrast?	N/A
N/A	Landing Slope (%)	N/A	N/A	DWS Length (in)	N/A
N/A	Landing X Slope (%)	N/A	N/A	DWS Full Width?	N/A
N/A	Landing Curb? (Y/N)	N/A	N/A	DWS Offset (in)	N/A
N/A	Shared Landing?	N/A			
N/A	Gutter Ponding?	N/A	N/A	Gutter Slope (%)	N/A
N/A	Gutter Lip Ht (in)	N/A	N/A	Gutter X Slope (%)	N/A
N/A	Painted X Walk1?	No	N/A	Painted X Walk2?	N/A
	X Walk 1 Direction	To NW		X Walk 2 Direction	N/A
N/A	X Walk 1 Width (in)	N/A	N/A	X Walk 2 Width (in)	N/A
	X Walk 1 Slope (%)	8.1		X Walk 2 Slope (%)	N/A
	X Walk 1 X Slope (%)	3.7		X Walk 2 X Slope (%)	N/A

N/A	Ramp inside XWalk1?	N/A	N/A	Ramp inside XWalk2?	N/A
	Road Slope (%)	N/A	N/A	Clear Space?	N/A
	Road X Slope (%)	N/A	N/A	Clear Space to XWalk (in)	N/A
N/A	Any Obstructions?	N/A	N/A	Storm Grate/Utility Hazard?	N/A
	Obstruction Type			Storm Grate/Utility Type	
		N/A			N/A
			Yes	Surface Condition? (G/P)	Good

**Remove & Replace Entire Ramp.**

Total Cost: \$ 1850.00
