# Access Compliance Report

## Public Rights-of-Way

### (Curb Ramps)

Intersection ID: 11499	Main Street: TIMBERTOP_LN	Cross Street: VERONICA_DR	Location: NW
ADA ID: D39A13B31926	Ramp Type: Perp	Initial Pass/Fail: Fail	Overall Compliance: No
		Severity Score: 10

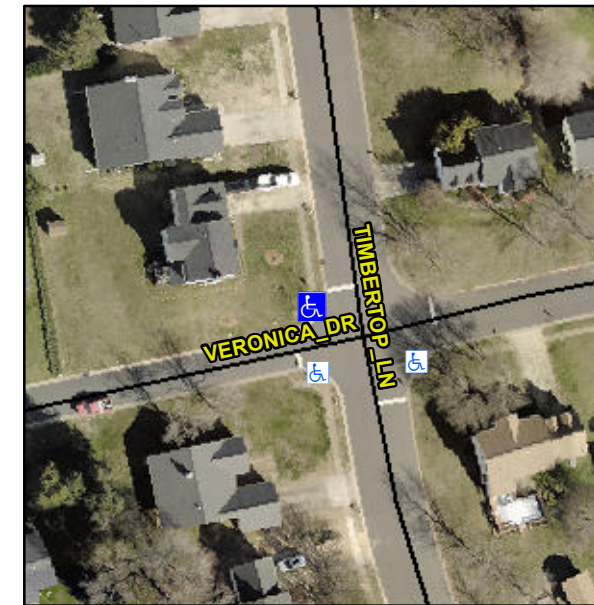
Compliance	Description	Data	Compliance	Description	Data
N/A	Ramp Length (in)	48.0	Yes	Ramp Slope (%)	6.8
No	Ramp Width (in)	42.0	No	Ramp XSlope (%)	4.4
N/A	Flare Type LT	N/A	N/A	Flare Type RT	N/A
N/A	Flare Slope LT (%)	N/A	N/A	Flare Slope RT (%)	N/A
N/A	Flare Traversable LT?	N/A	N/A	Flare Traversable RT?	N/A
N/A	Landing Length (in)	N/A	N/A	DWS Provided?	N/A
N/A	Landing Width (in)	N/A	N/A	DWS Contrast?	N/A
N/A	Landing Slope (%)	N/A	N/A	DWS Length (in)	N/A
N/A	Landing X Slope (%)	N/A	N/A	DWS Full Width?	N/A
N/A	Landing Curb? (Y/N)	N/A	N/A	DWS Offset (in)	N/A
N/A	Shared Landing?	N/A			
N/A	Gutter Ponding?	N/A	N/A	Gutter Slope (%)	N/A
N/A	Gutter Lip Ht (in)	N/A	N/A	Gutter X Slope (%)	N/A
N/A	Painted X Walk1?	No	N/A	Painted X Walk2?	N/A
	X Walk 1 Direction	To S		X Walk 2 Direction	N/A
N/A	X Walk 1 Width (in)	N/A	N/A	X Walk 2 Width (in)	N/A
	X Walk 1 Slope (%)	2.0		X Walk 2 Slope (%)	N/A
	X Walk 1 X Slope (%)	4.6		X Walk 2 X Slope (%)	N/A

N/A	Ramp inside XWalk1?	N/A	N/A	Ramp inside XWalk2?	N/A
	Road Slope (%)	N/A	N/A	Clear Space?	N/A
	Road X Slope (%)	N/A	N/A	Clear Space to XWalk (in)	N/A
N/A	Any Obstructions?	N/A	N/A	Storm Grate/Utility Hazard?	N/A
	Obstruction Type			Storm Grate/Utility Type	
		N/A			N/A
			Yes	Surface Condition? (G/P)	Good

Possible Solutions:

**Remove & Replace Entire Ramp.**

**R304.5.1, R304.5.3**
