# Access Compliance Report

## Public Rights-of-Way

### (Curb Ramps)

Intersection ID: 43154	Main Street: KILDARE_DR	Cross Street: SHANNONHOUSE_DR	Location: SW
ADA ID: D3ADCDC3A61E	Ramp Type: Directional1	Initial Pass/Fail: Fail	Overall Compliance: No
Severity Score: 25			
Codes/Mitigation Info/Possible Solution		Field Measurements/Component Compliance

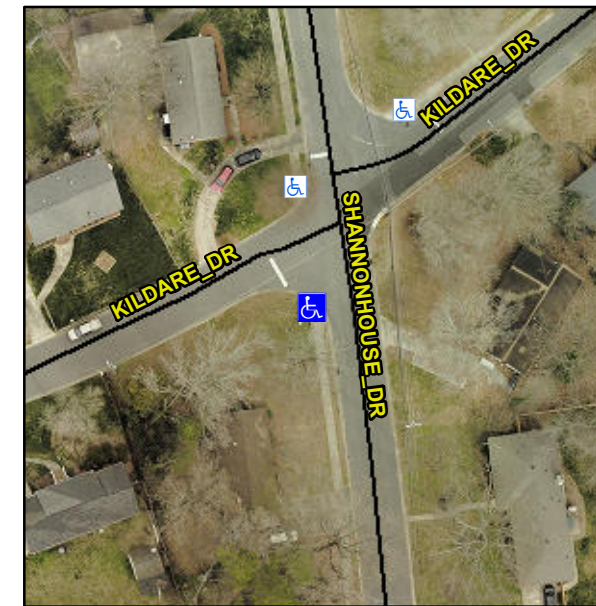
Compliance	Description	Data	Compliance	Description	Data
N/A	Ramp Length (in)	147.5	N/A	Grade Break?	N/A
Yes	Ramp Width (in)	61.5	N/A	Grade Break Slope (%)	0.0
No	Ramp Slope (%)	16.0	N/A	Grade Break XSlope (%)	0.0
Yes	Ramp XSlope (%)	1.9			
N/A	Flare Type LT	N/A	N/A	Flare Type RT	N/A
N/A	Flare Slope LT (%)	N/A	N/A	Flare Slope RT (%)	0.0
N/A	Flare Traversable LT?	N/A	N/A	Flare Traversable RT?	N/A
N/A	Landing Length (in)	0.0	N/A	DWS Provided?	N/A
N/A	Landing Width (in)	0.0	N/A	DWS Contrast?	N/A
N/A	Landing Slope (%)	0.0	N/A	DWS Length (in)	N/A
N/A	Landing X Slope (%)	0.0	N/A	DWS Full Width?	N/A
N/A	Landing Curb? (Y/N)	N/A	N/A	DWS Offset LT (in)	N/A
N/A	Shared Landing?	N/A	N/A	DWS Offset RT (in)	N/A
N/A	Gutter Ponding?	0.0	N/A	Gutter Slope (%)	N/A
N/A	Gutter Lip Ht (in)	1.0	N/A	Gutter X Slope (%)	N/A
N/A	Painted X Walk1?	No		Road Slope (%)	3.0
	X Walk 1 Direction	To N		Road X Slope (%)	3.8
	X Walk 1 Width (in)	N/A		Clear Space?	N/A

X Walk 1 Slope (%)	3.0	N/A	Clear Space to XWalk (in)	N/A
	X Walk 1 X Slope (%)	3.8	N/A	Storm Grate/Utility Hazard?	N/A
N/A	Ramp inside XWalk1?	N/A		Storm Grate/Utility Type	
N/A	Any Obstructions?	N/A			N/A
	Obstruction Type		Yes	Surface Condition? (G/P)	Good
			N/A	Curb Slope (%)	13.7

Possible Solutions:

**Remove & Replace Entire Ramp.**

**R304.2.2**
