Access Compliance Report

Public Rights-of-Way

(Curb Ramps)

| Intersection ID: 32296 | Main Street: BAILEYWICK_RD | Cross Street: LISHA_LN | Location: NW |

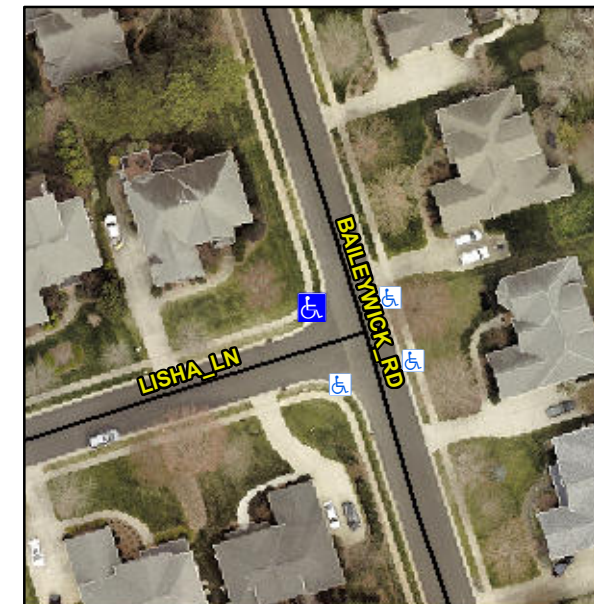
Not Found, R304.5.1, R304.5.3

| Compliance | Description | Data | Compliance | Description | Data |
|---|---|---|---|---|---|
| N/A | Ramp Length (in) | 50.0 | Yes | Ramp Slope (%) | 6.8 |
| No | Ramp Width (in) | 47.5 | No | Ramp XSlope (%) | 6.3 |

Remove & Replace Curb Ramp With Two New Directional Ramps or Equivalent.

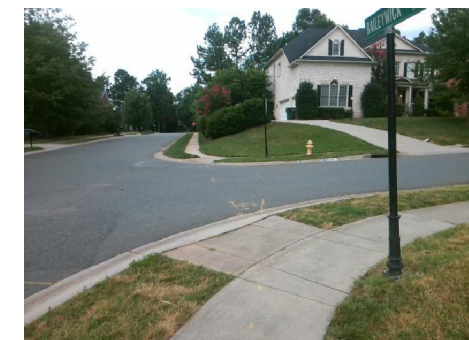
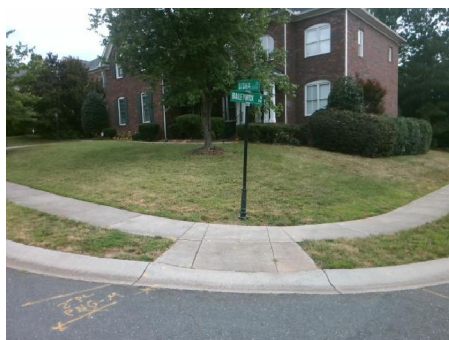
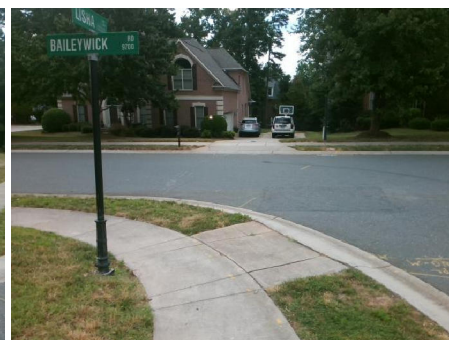
| Compliance | Description | Data | Compliance | Description | Data |
|---|---|---|---|---|---|
| | | Yes | | Surface Condition? (G/P) | Good |
