# Access Compliance Report

## Public Rights-of-Way

### (Curb Ramps)

| Intersection ID: 48453 | Main Street: ALVARADO_WY | Cross Street: RED_RUST_LN | Location: NW |

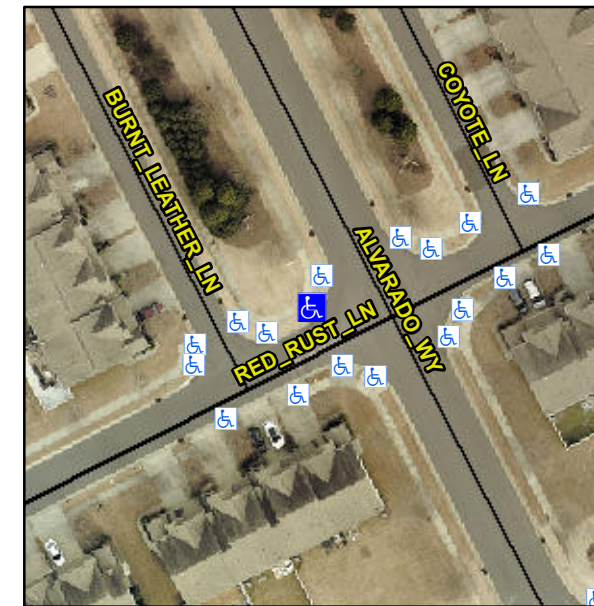
| ADA ID: D3B03F4170E3 | Ramp Type: Perp | Initial Pass/Fail: Fail | Overall Compliance: No |
| | | Severity Score: 10 | |

**R304.5.1, R304.5.3**

| Compliance | Description | Data | Compliance | Description | Data |
|---|---|---|---|---|---|
| N/A | Ramp Length (in) | 133.0 | Yes | Ramp Slope (%) | 6.2 |
| No | Ramp Width (in) | 47.0 | No | Ramp XSlope (%) | 4.0 |

**Remove & Replace Entire Ramp.**

Total Cost: \$ 1850.00
