# Access Compliance Report

## Public Rights-of-Way

### (Curb Ramps)

Intersection ID: 12356	Main Street: BOST_ST	Cross Street: CRISPIN_AV	Location: SE
ADA ID: D3B44D52353E	Ramp Type: Para	Initial Pass/Fail: Fail	Overall Compliance: No
Severity Score: 13.75			
Codes/Mitigation Info/Possible Solution		Field Measurements/Component Compliance

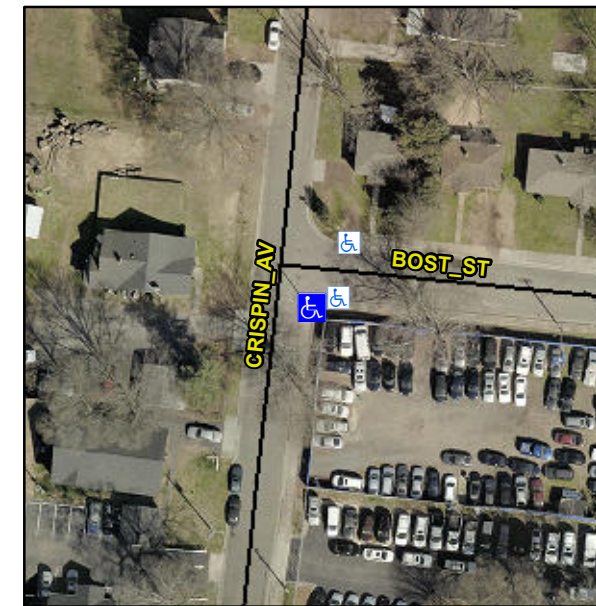
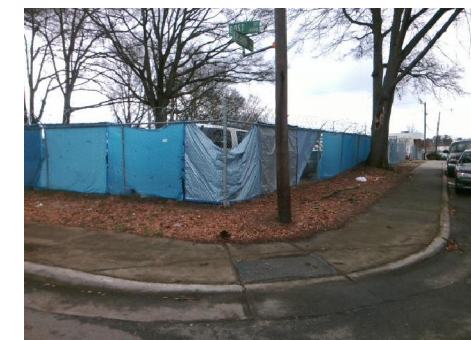
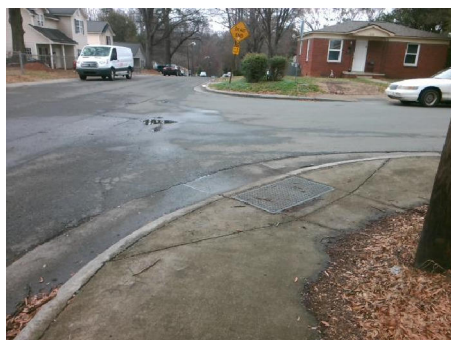
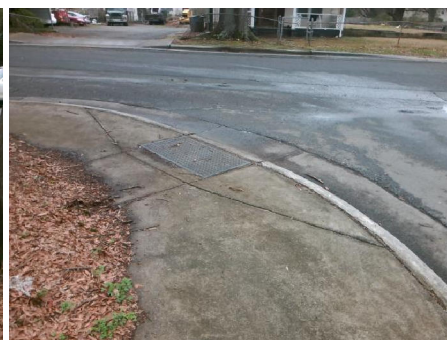
Compliance	Description	Data	Compliance	Description	Data
N/A	Ramp Length LT (in)	80.0	N/A	Ramp Length RT (in)	80.0
Yes	Ramp Width LT (in)	72.0	Yes	Ramp Width RT (in)	72.0
Yes	Ramp Slope LT (%)	5.2	No	Ramp Slope RT (%)	9.3
Yes	Ramp XSlope LT (%)	0.9	No	Ramp XSlope RT (%)	3.8
N/A	Landing Length (in)	N/A	N/A	DWS Provided?	N/A
N/A	Landing Width (in)	N/A	N/A	DWS Contrast?	N/A
N/A	Landing Slope (%)	N/A	N/A	DWS Length (in)	N/A
N/A	Landing X Slope (%)	N/A	N/A	DWS Full Width?	N/A
N/A	Landing Curb? (Y/N)	N/A	N/A	DWS Offset (in)	N/A
N/A	Shared Landing?	N/A			
N/A	Gutter Ponding?	N/A	N/A	Gutter Slope (%)	N/A
N/A	Gutter Lip Ht (in)	N/A	N/A	Gutter X Slope (%)	N/A
N/A	Painted X Walk1?	No	N/A	Painted X Walk2?	N/A
	X Walk 1 Direction	To N		X Walk 2 Direction	N/A
N/A	X Walk 1 Width (in)	N/A	N/A	X Walk 2 Width (in)	N/A
	X Walk 1 Slope (%)	0.3		X Walk 2 Slope (%)	N/A
	X Walk 1 X Slope (%)	0.2		X Walk 2 X Slope (%)	N/A
N/A	Ramp inside XWalk1?	N/A	N/A	Ramp inside XWalk2?	N/A

Road Slope (%)	N/A	N/A	Clear Space?	N/A
	Road X Slope (%)	N/A	N/A	Clear Space to XWalk (in)	N/A
N/A	Any Obstructions?	N/A	N/A	Storm Grate/Utility Hazard?	N/A
	Obstruction Type			Storm Grate/Utility Type	
		N/A			N/A
			Yes	Surface Condition? (G/P)	Good
			N/A	Curb Slope (%)	11.7

**Remove & Replace Entire Ramp.**

**R304.3.2, R304.5.3**
